## Pensacola Community Redevelopment Agency

CRA Sidewalk and ADA Accessibility Street Revitalization Projects

A Street, DeVilliers Street, Reus Street

Public Meeting March 19, 2019

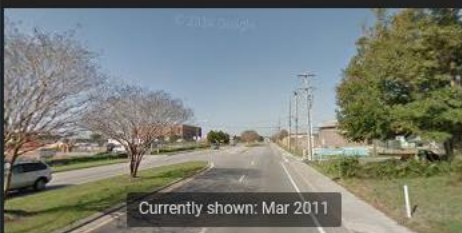
Street View - Mar 2011

Main Street had narrow sidewalks, marginal space for bicycles, and no landscape or street lighting. High speeds made walking along the sidewalk against speeding traffic feel unsafe.

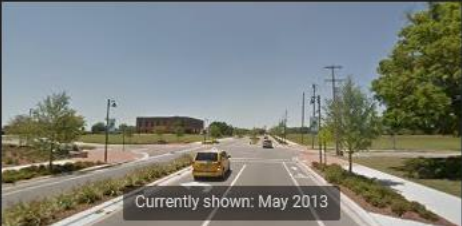
Street View - May 2013

The Main Street “road diet”, the removal of the treatment plant, and the development and construction of the Community Maritime Park thoroughly revitalized the corridor. The street now includes 8- to 10-foot wide landscaped green space, appropriate lighting, a standard bike lane, and an 8- to 10-foot sidewalk.

Traffic now moves more slowly allowing bike riders and pedestrians to feel more comfortable.

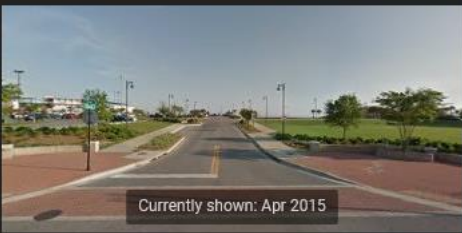
Street View - Apr 2015

This intersection is DeVilliers at Main Street leading into Community Maritime Park with the paver plazas.

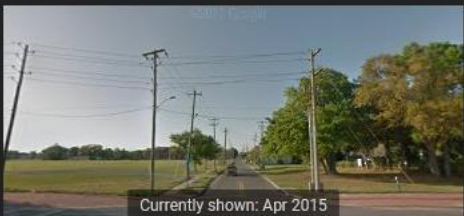
Street View - Apr 2015

Walking north along DeVilliers Street, or riding a bike on the street are not comfortable options, so the street rebalancing for all users is necessary. Wider sidewalks, reconstructed to be compliant with Americans with Disabilities Act (ADA) rules is necessary. Perhaps adding “sharrows” to remind drivers to share the road would be advised.

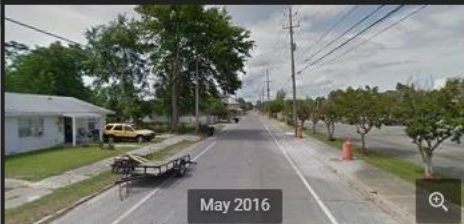
Street View - Jun 2018

After repaving the parking lanes were not striped so parking here is informal and can occur on either side of the street.

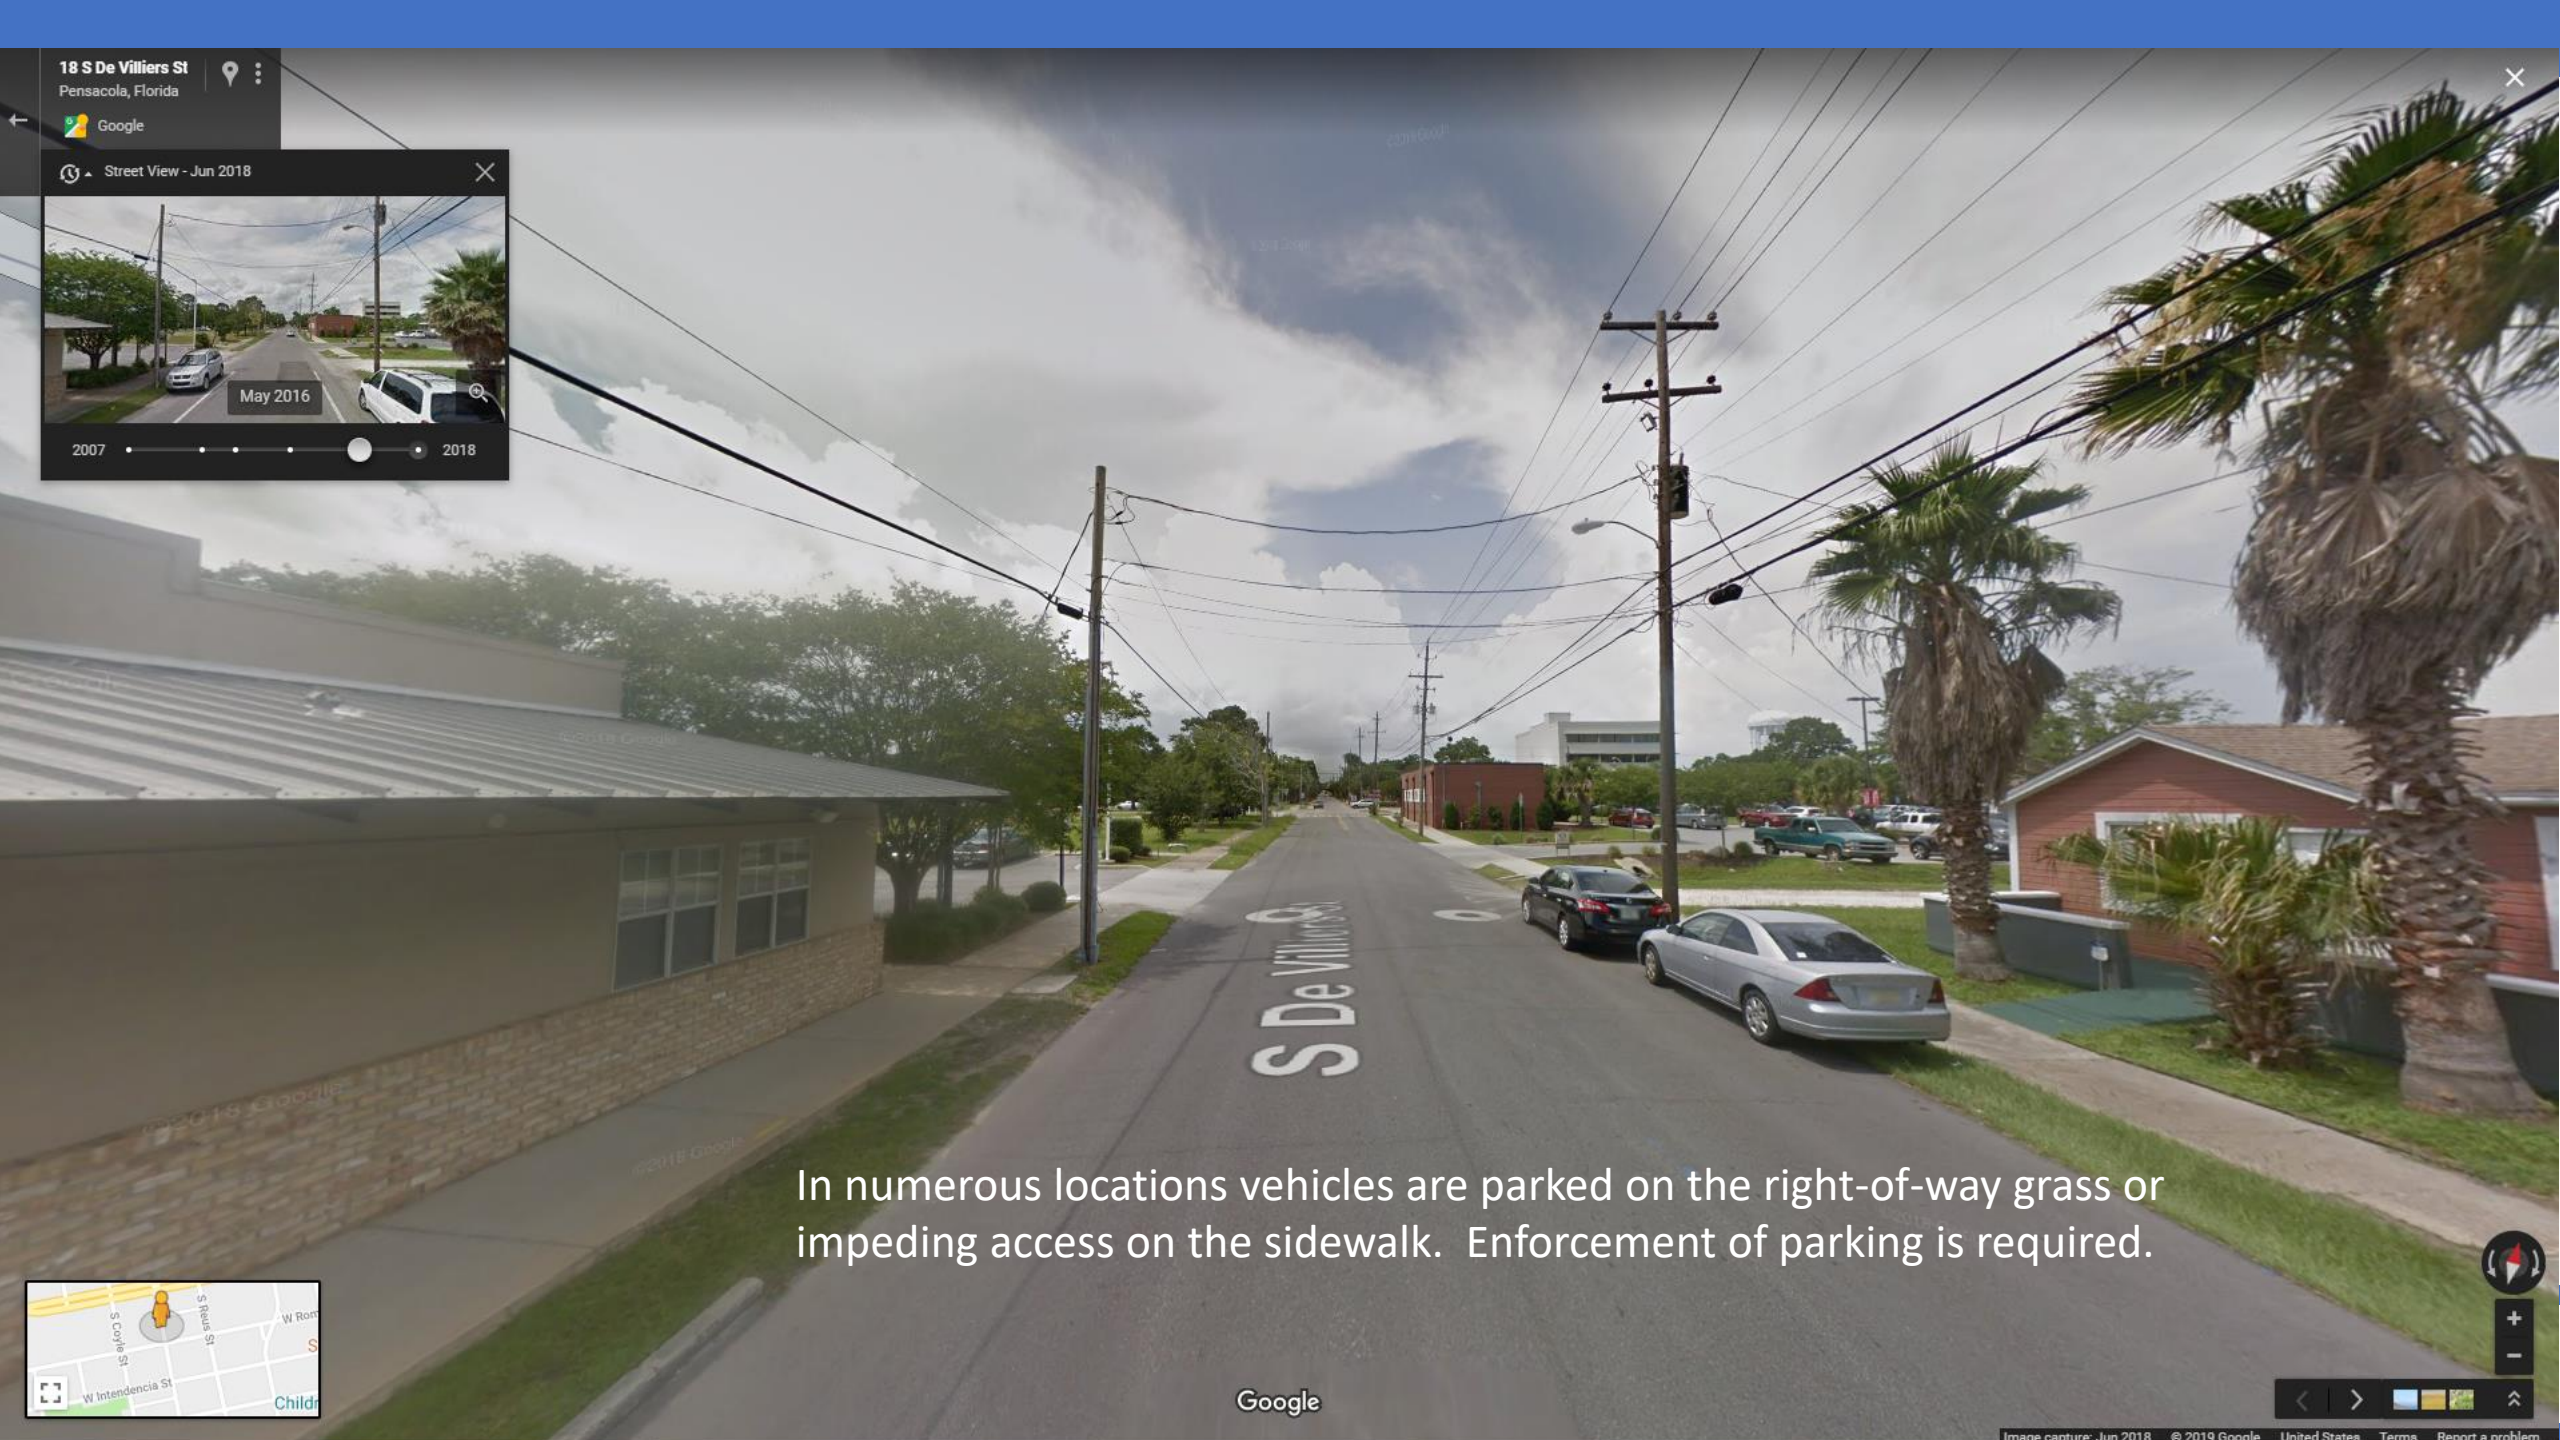
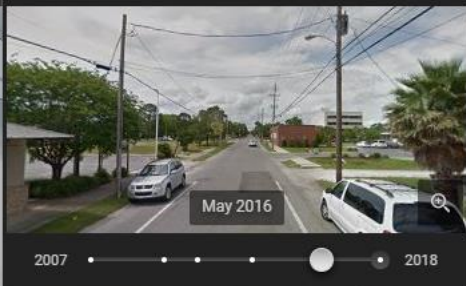
18 S De Villiers St

In numerous locations vehicles are parked on the right-of-way grass or impeding access on the sidewalk. Enforcement of parking is required.

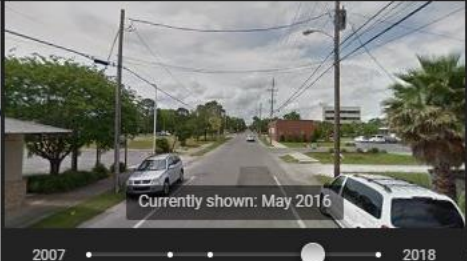
Street View - May 2016

Here, in the same location, cars are fully or partially parked on the street, however the striping no longer exists.

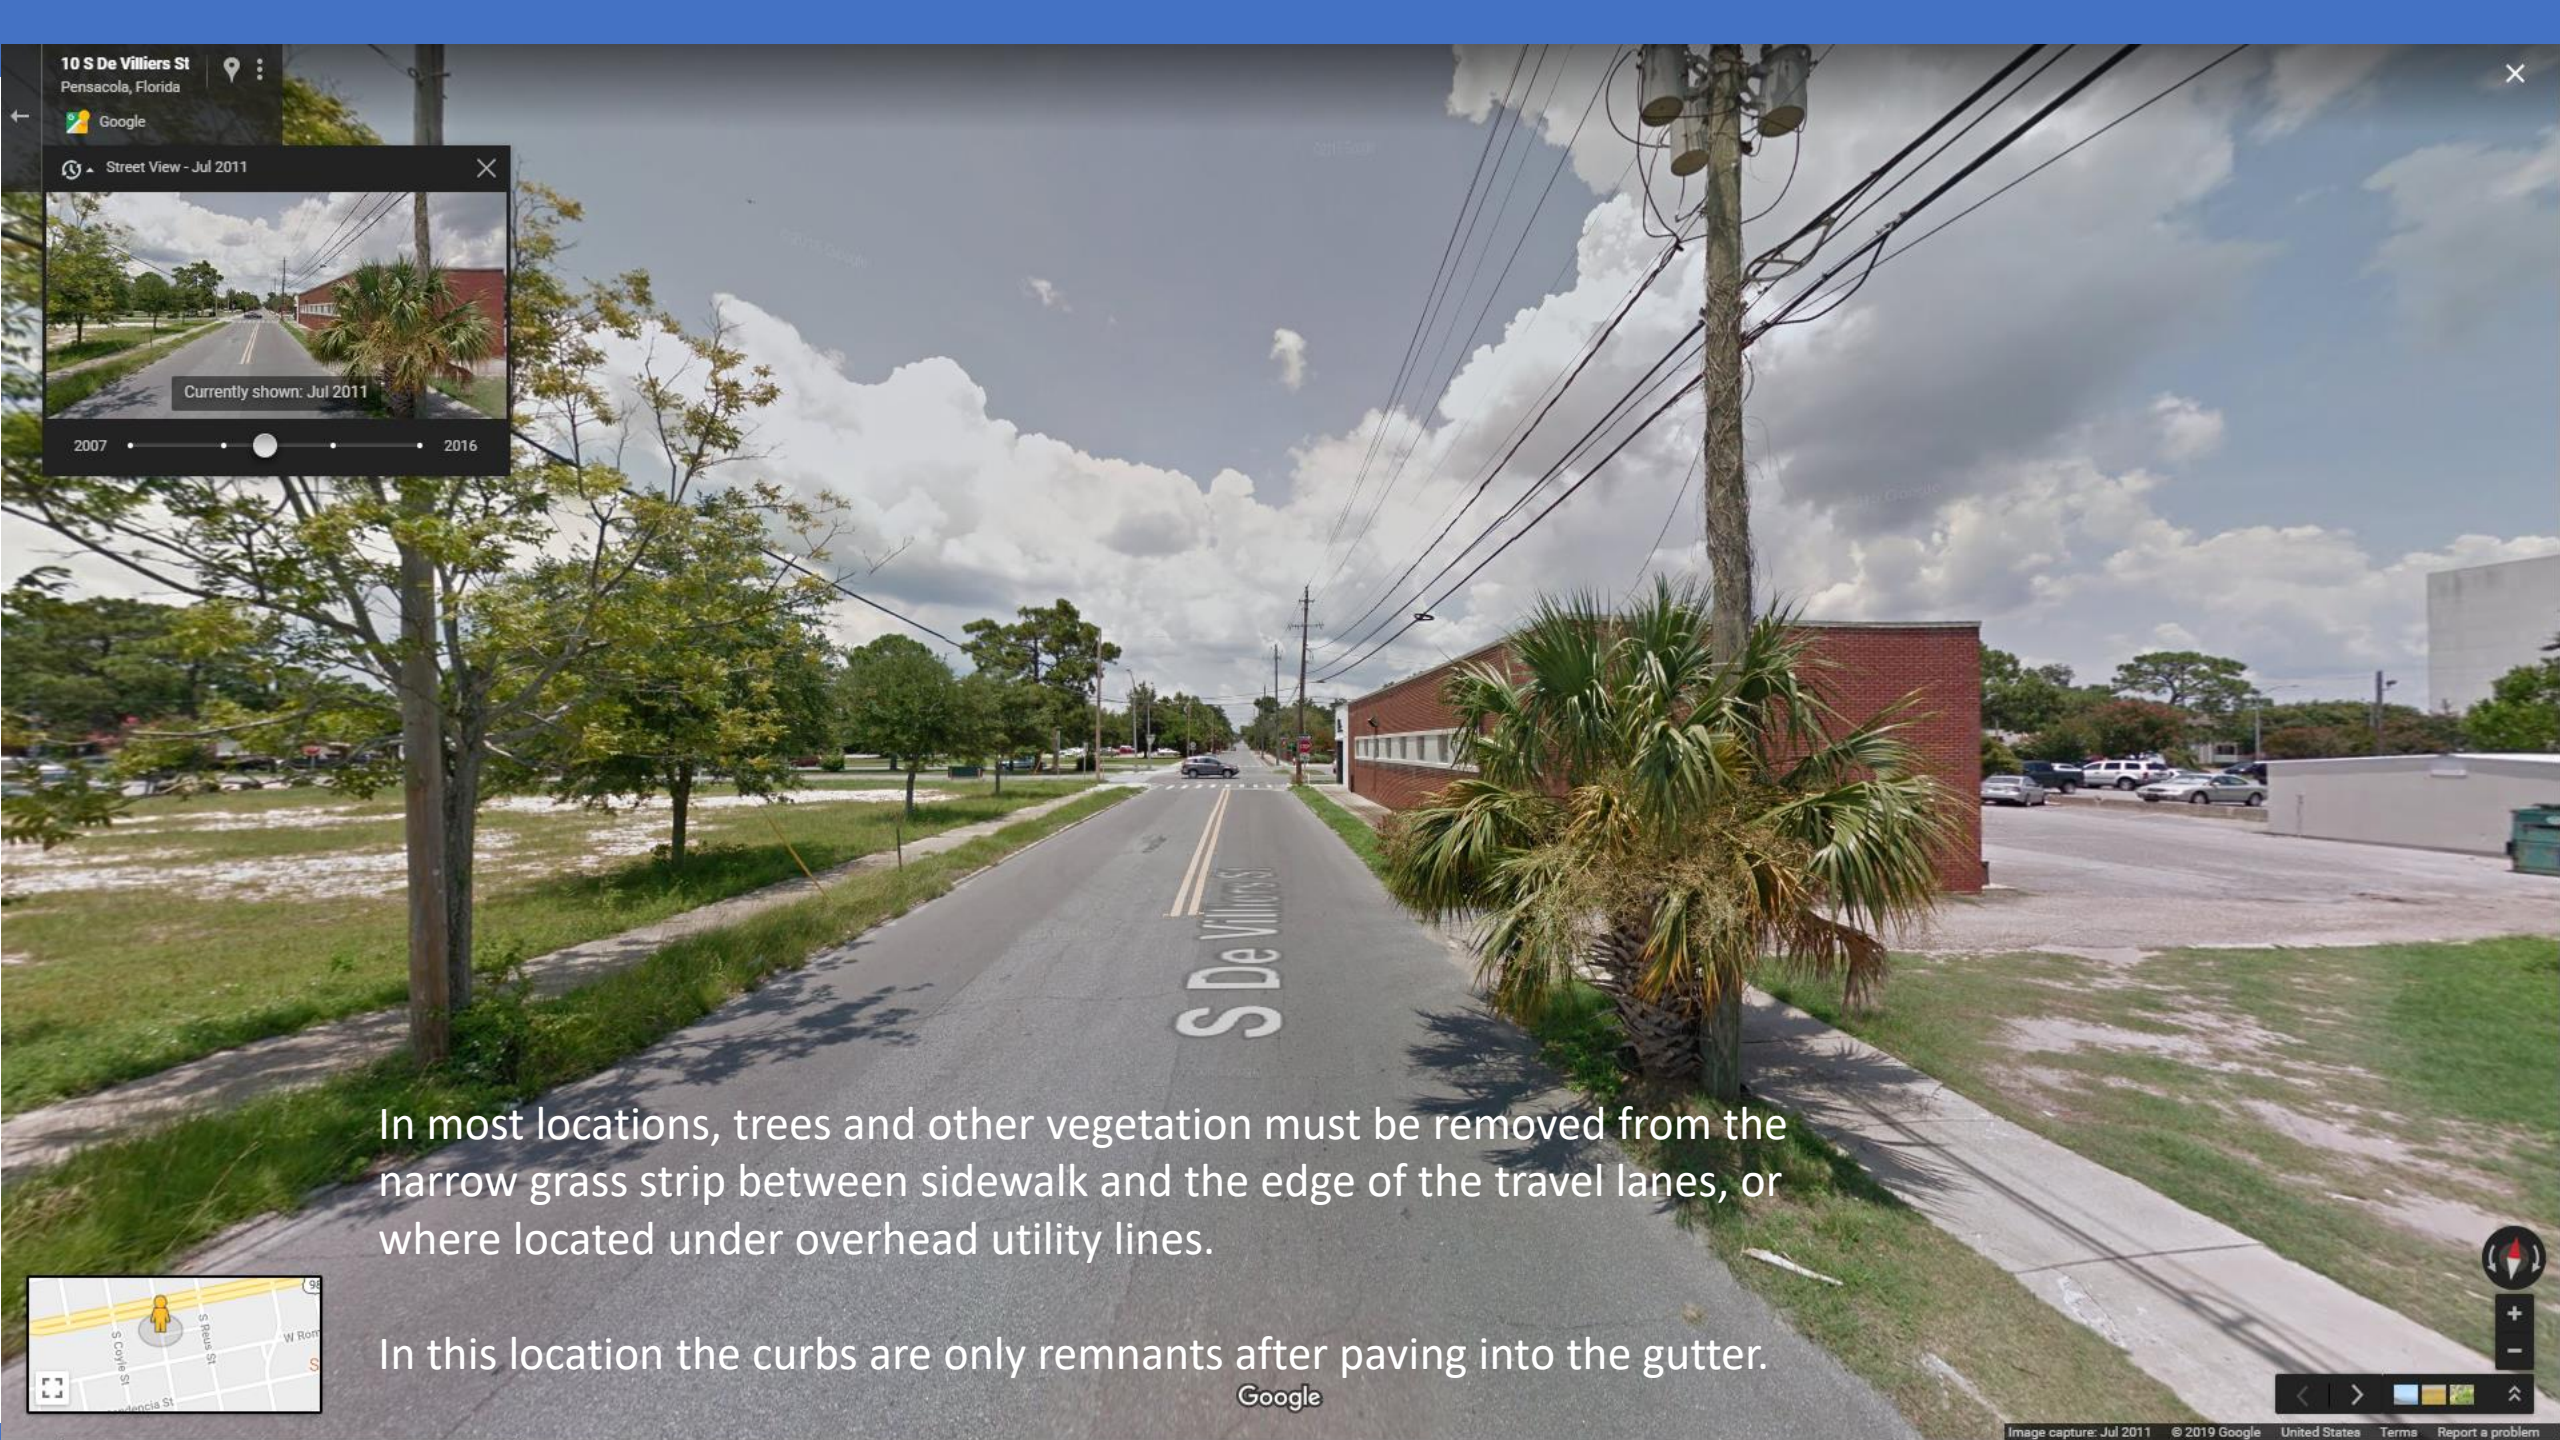
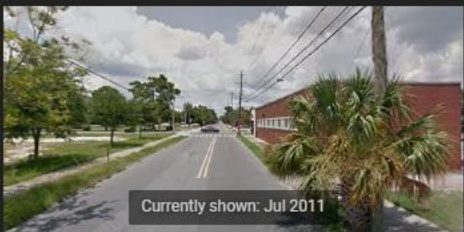
10 S De Villiers St  
Pensacola, Florida

In most locations, trees and other vegetation must be removed from the narrow grass strip between sidewalk and the edge of the travel lanes, or where located under overhead utility lines.

In this location the curbs are only remnants after paving into the gutter.

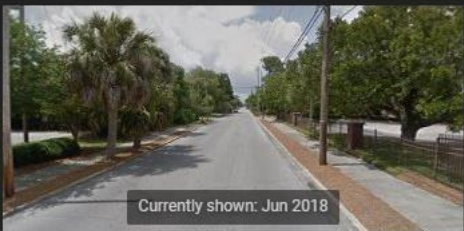
Street View - Jun 2018

Trees within the narrow "green strip" are recommended for removal to clear overhead and over the street obstructions.

It is recommended that the construction contract include tree and vegetation trimming and removal as well as pressure-washing any compliant sidewalks determined to remain.

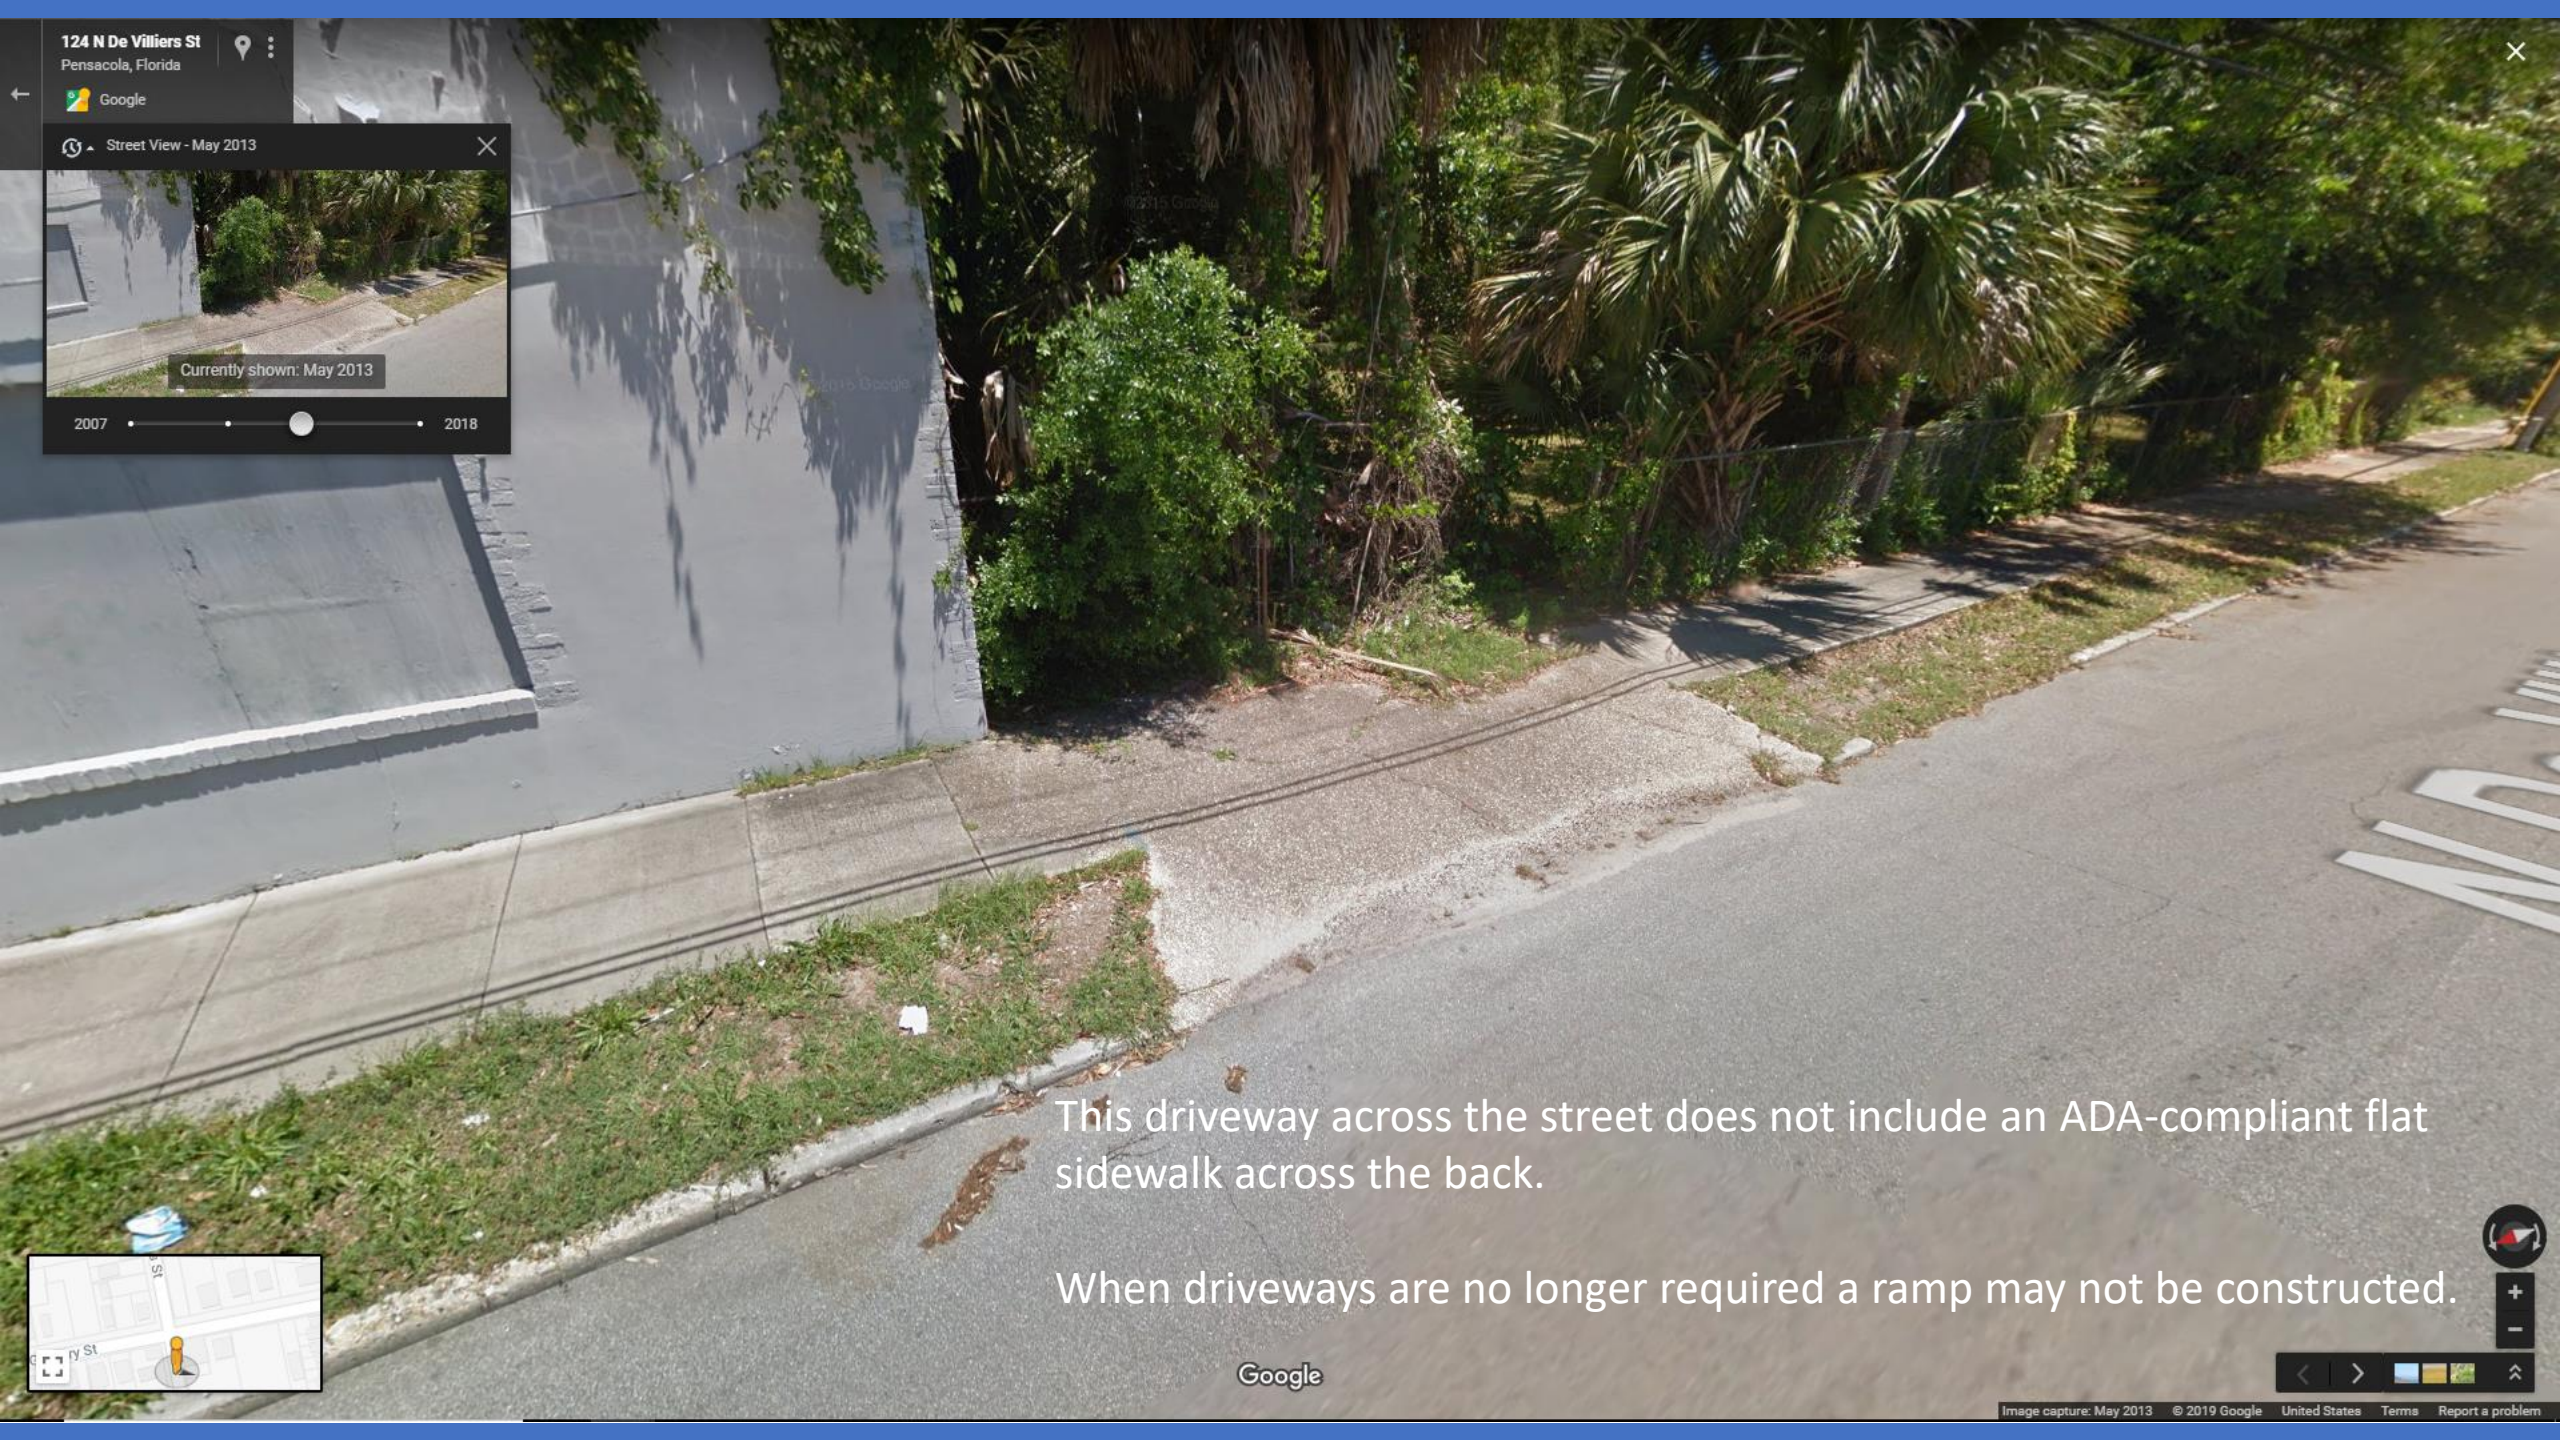
In numerous cases, existing driveway ramps and adjacent sidewalks have been damaged by vehicles crossing the driveway. In most cases these driveways will be replaced with a City of Pensacola standard driveway ramp with an ADA-compliant flat sidewalk at the back side of the ramp.

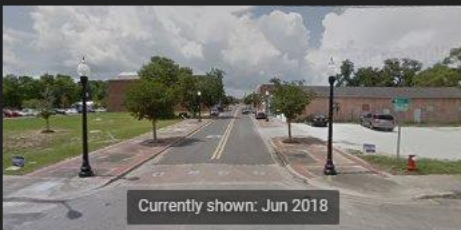
Street View - Jun 2018

No new construction is proposed within the Belmont-DeVilliers district, however restoration of some loose paver bricks may be added to the contract for repair.

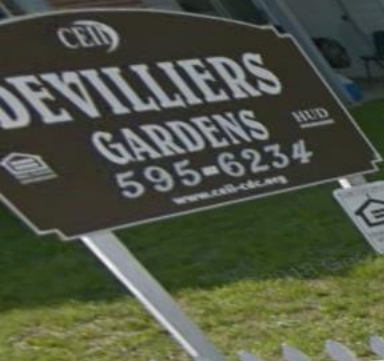
500 N De Villiers St  
Pensacola, Florida  
Google  
Street View - Jun 2018

In some locations ADA-accessible sidewalk ramps will be constructed on each corner at the intersection. Grass strip slopes, utility conflicts, drainage structures, and irregular asphalt paving make replacing with compliant curb ramps difficult.

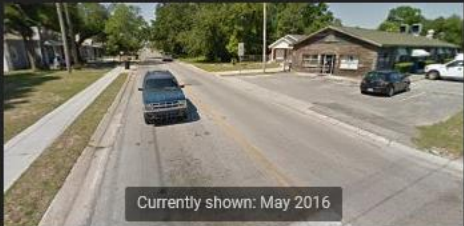
Street View - May 2016

This sidewalk on the west side will be replaced.

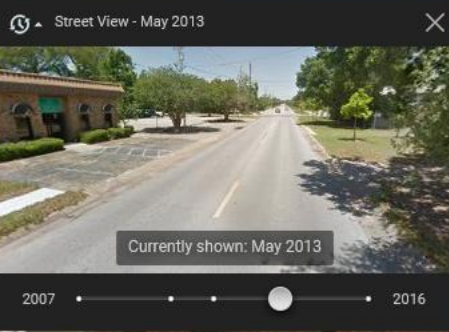
317 A Street  
Pensacola, Florida

The new sidewalk on the west side ends at the parking lot for this commercial building. Parking at this location backs into the street. The right-of-way line is near the front wall of the building. If new sidewalk is constructed on the same path along the street, the accessible path would run through the handicap spaces.

A sidewalk is proposed across the front of this site, however coordination of the route is essential.

A new sidewalk will be constructed along the east side of the street.

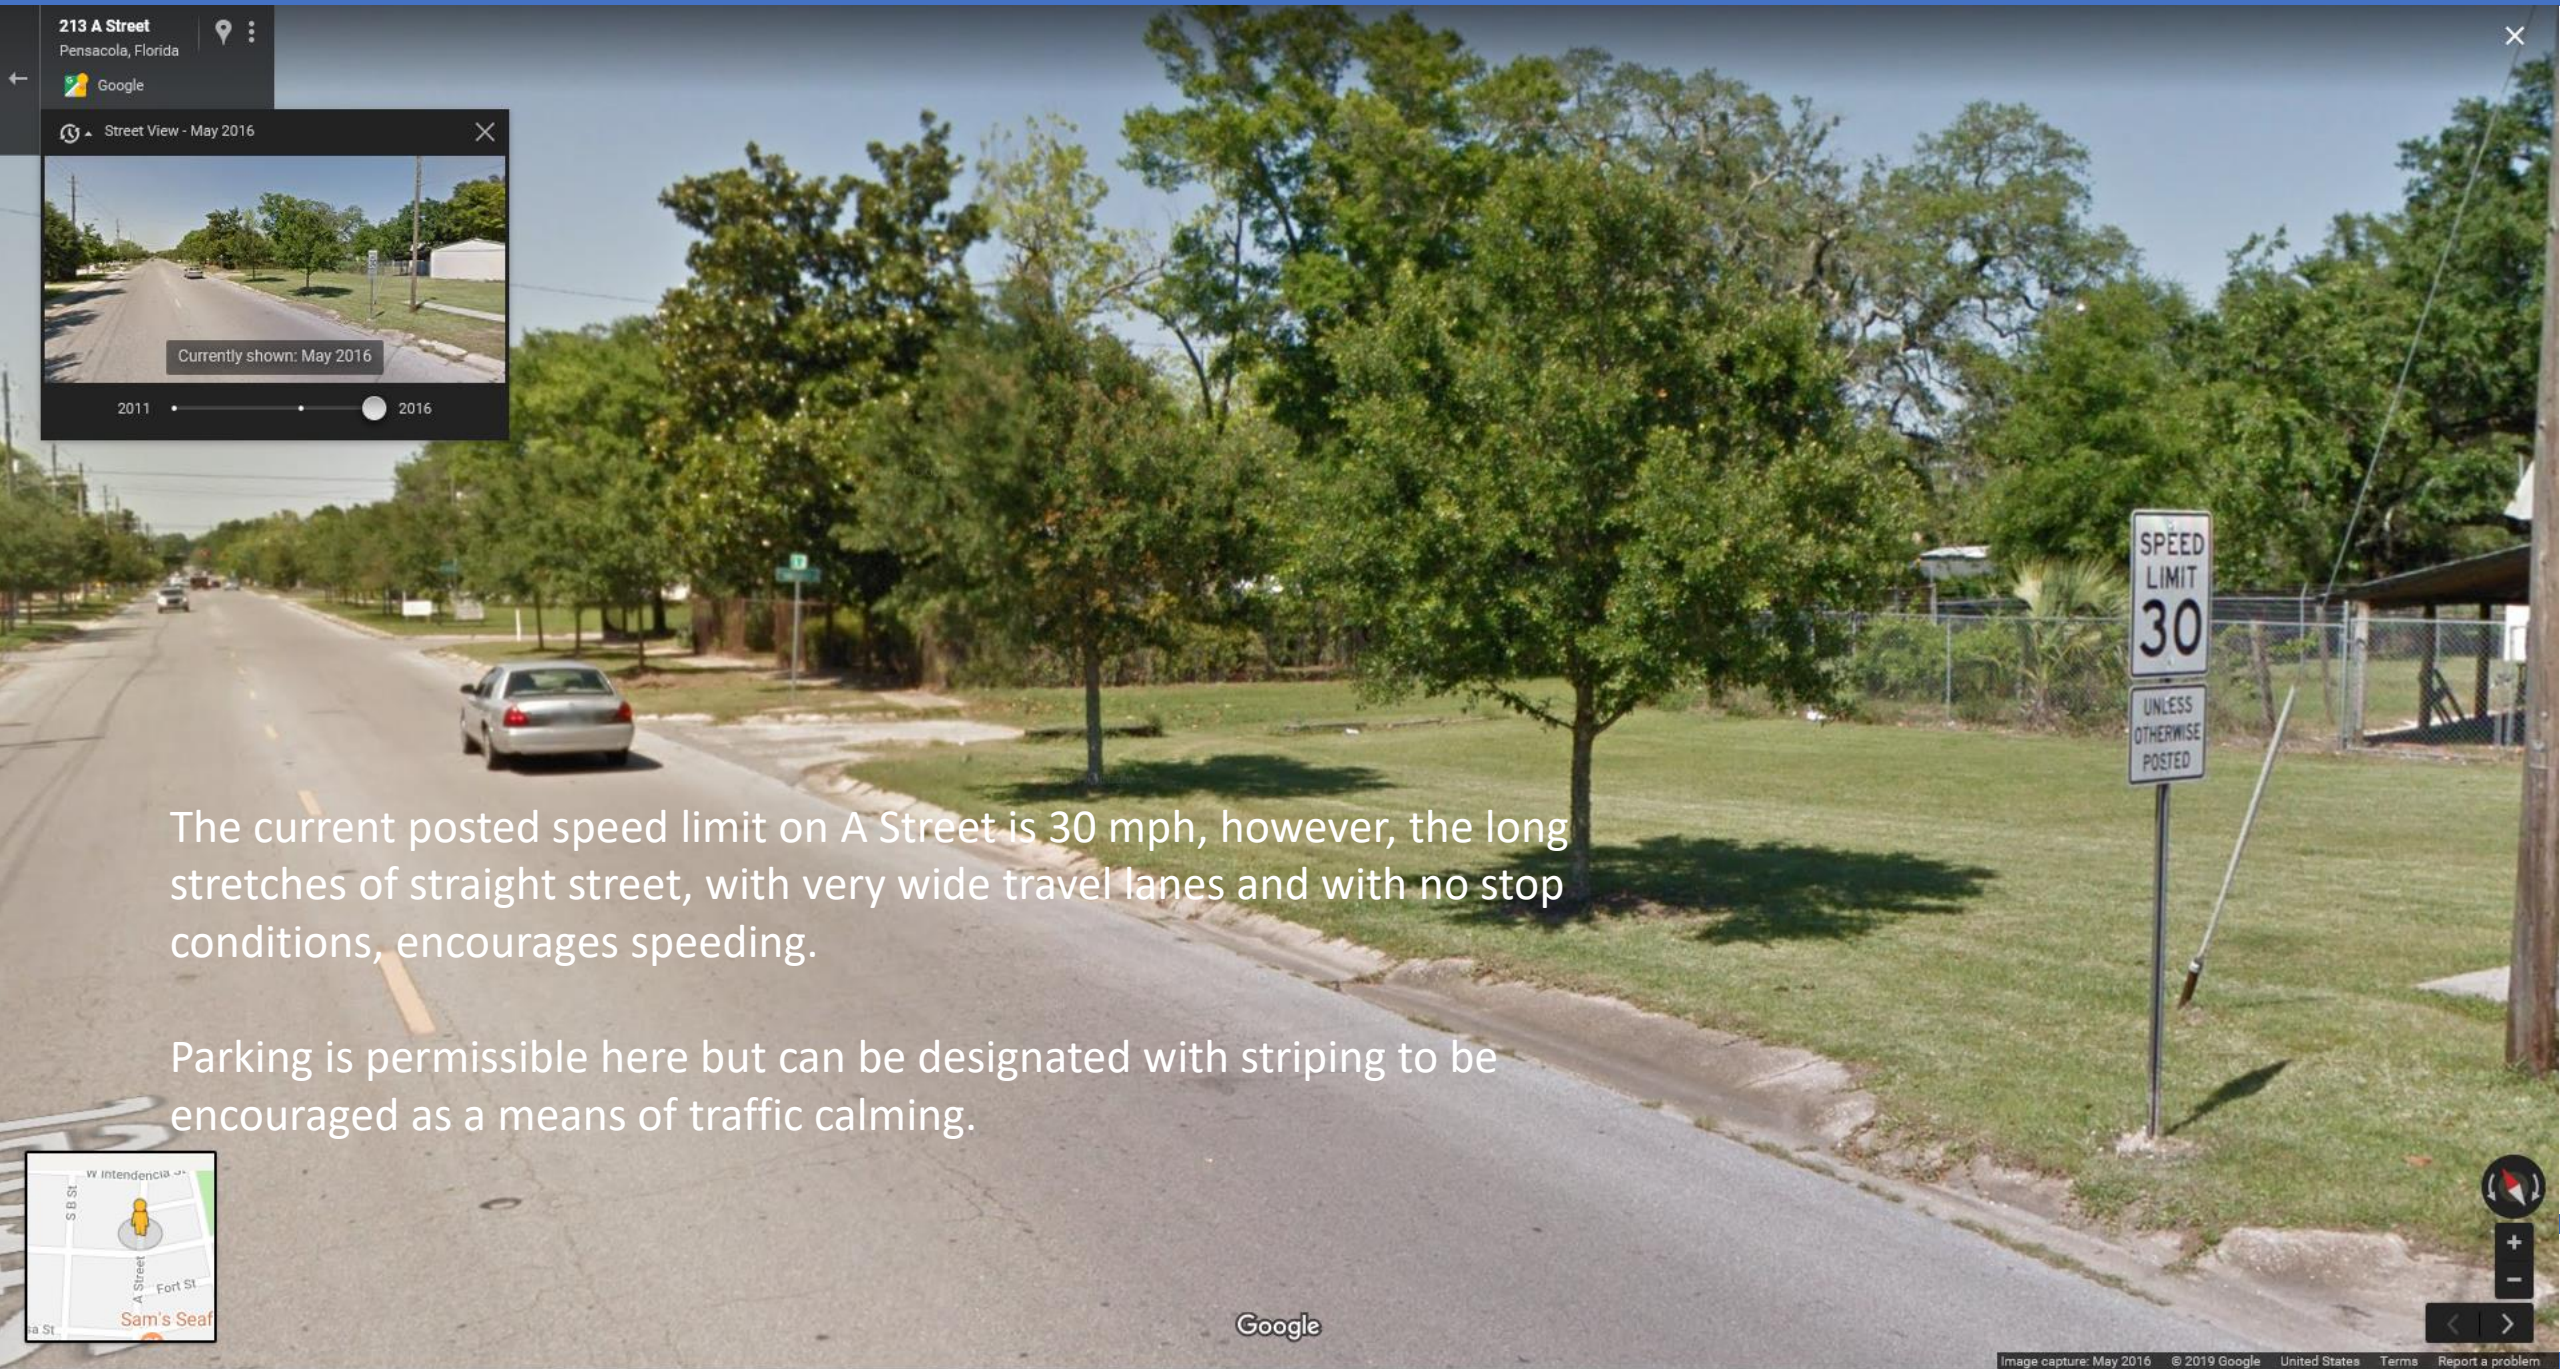
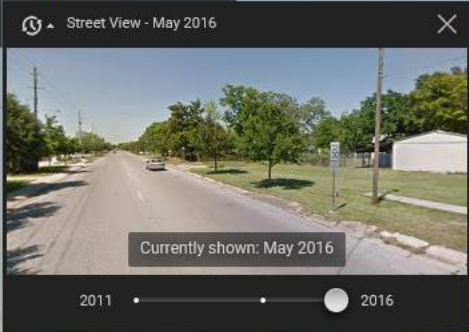
213 A Street  
Pensacola, Florida

The current posted speed limit on A Street is 30 mph, however, the long stretches of straight street, with very wide travel lanes and with no stop conditions, encourages speeding.

Parking is permissible here but can be designated with striping to be encouraged as a means of traffic calming.

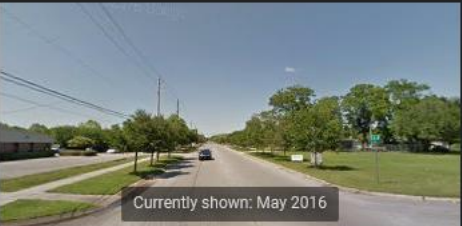
Street View - May 2016

The east side of A Street immediately north of Intendencia Street currently does not have sidewalks.

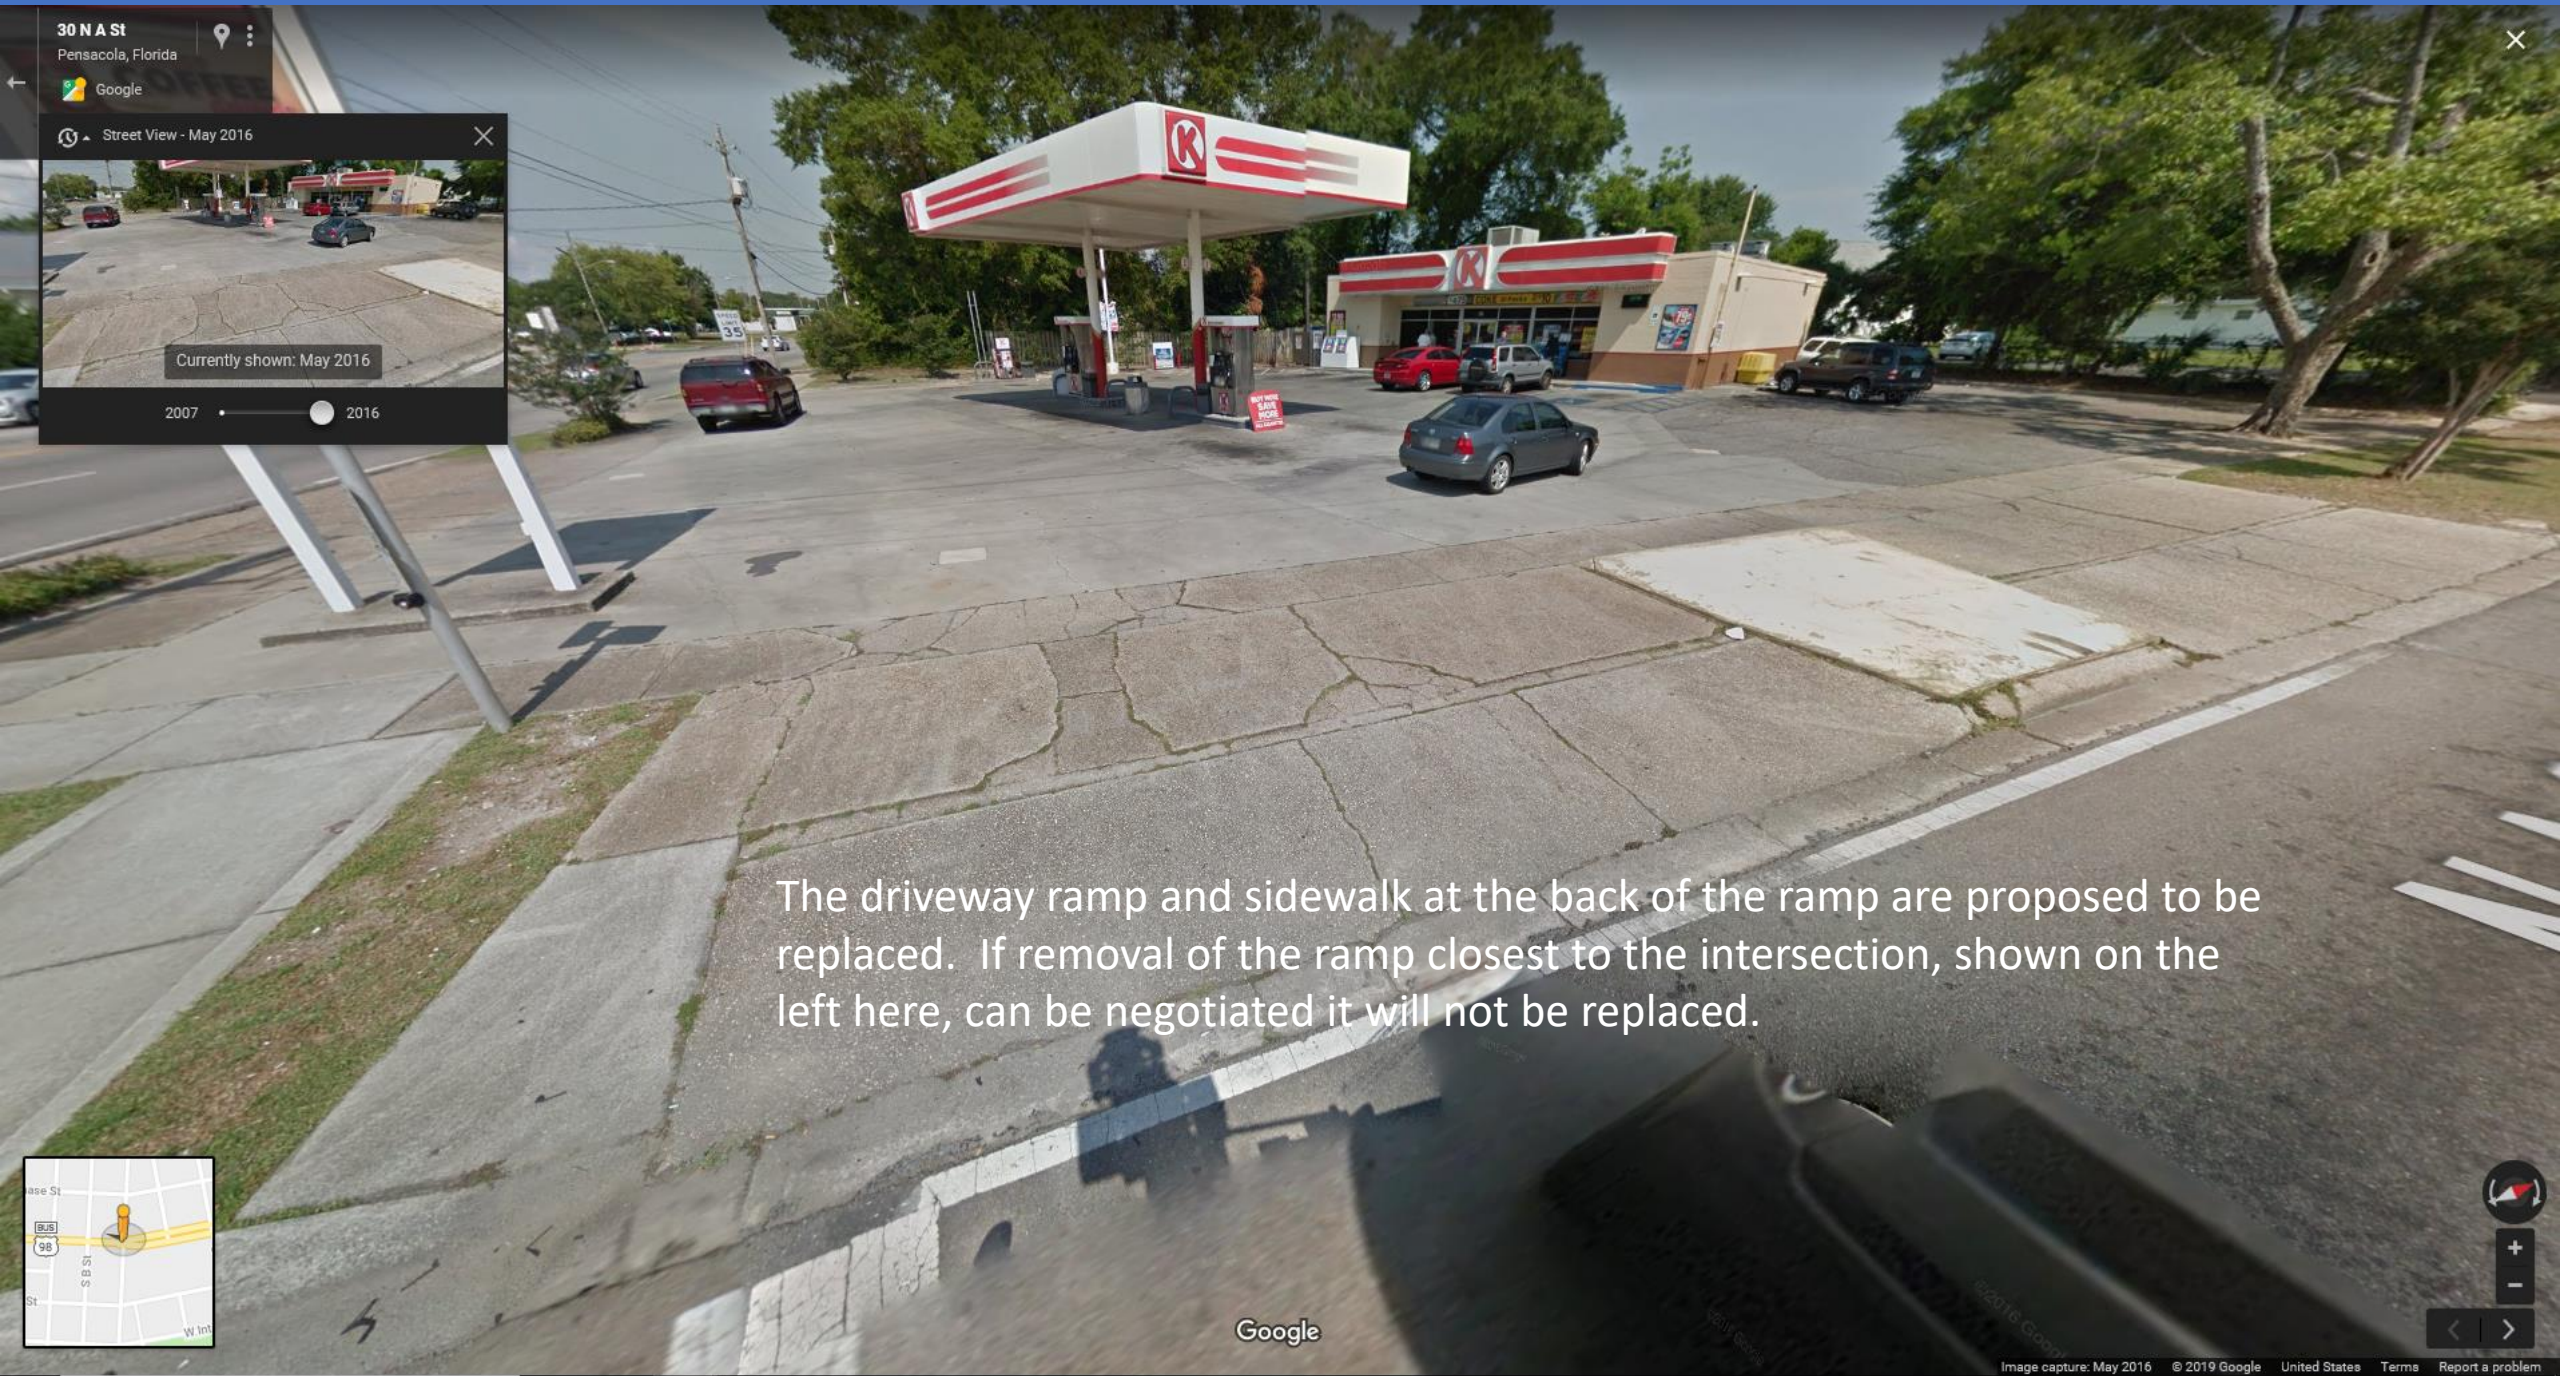
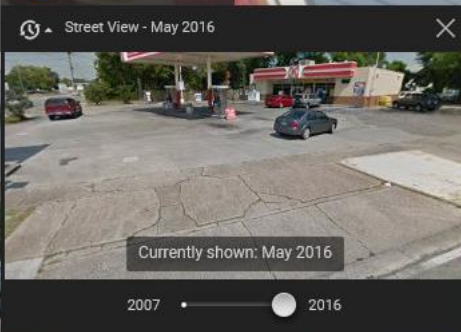
30 N A St  
Pensacola, Florida

The driveway ramp and sidewalk at the back of the ramp are proposed to be replaced. If removal of the ramp closest to the intersection, shown on the left here, can be negotiated it will not be replaced.

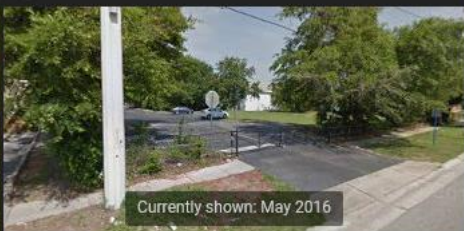
Street View - May 2016

In locations as shown here the sidewalk is proposed to be replaced. The driveway and ramp will also be replaced.

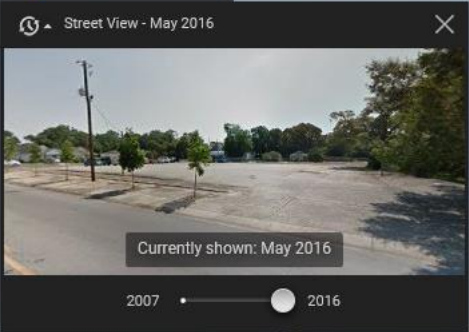
110 A Street  
Pensacola, Florida

In this location several options have been considered; removal of much of the concrete within the right-of-way except for the wide driveway ramp may be the option selected.

The trees in the tree wells are living but not thriving due to lack of irrigation.

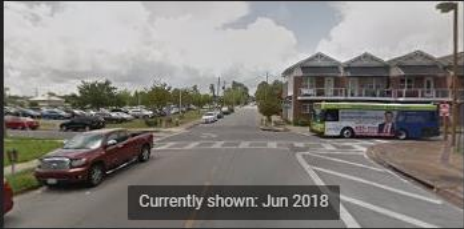
Reus Street narrows after the Intendencia Street one-way street intersection.
