## Pensacola Community Redevelopment Agency

CRA Sidewalk and ADA Accessibility Street Revitalization Projects

A Street, DeVilliers Street, Reus Street

Public Meeting March 19, 2019

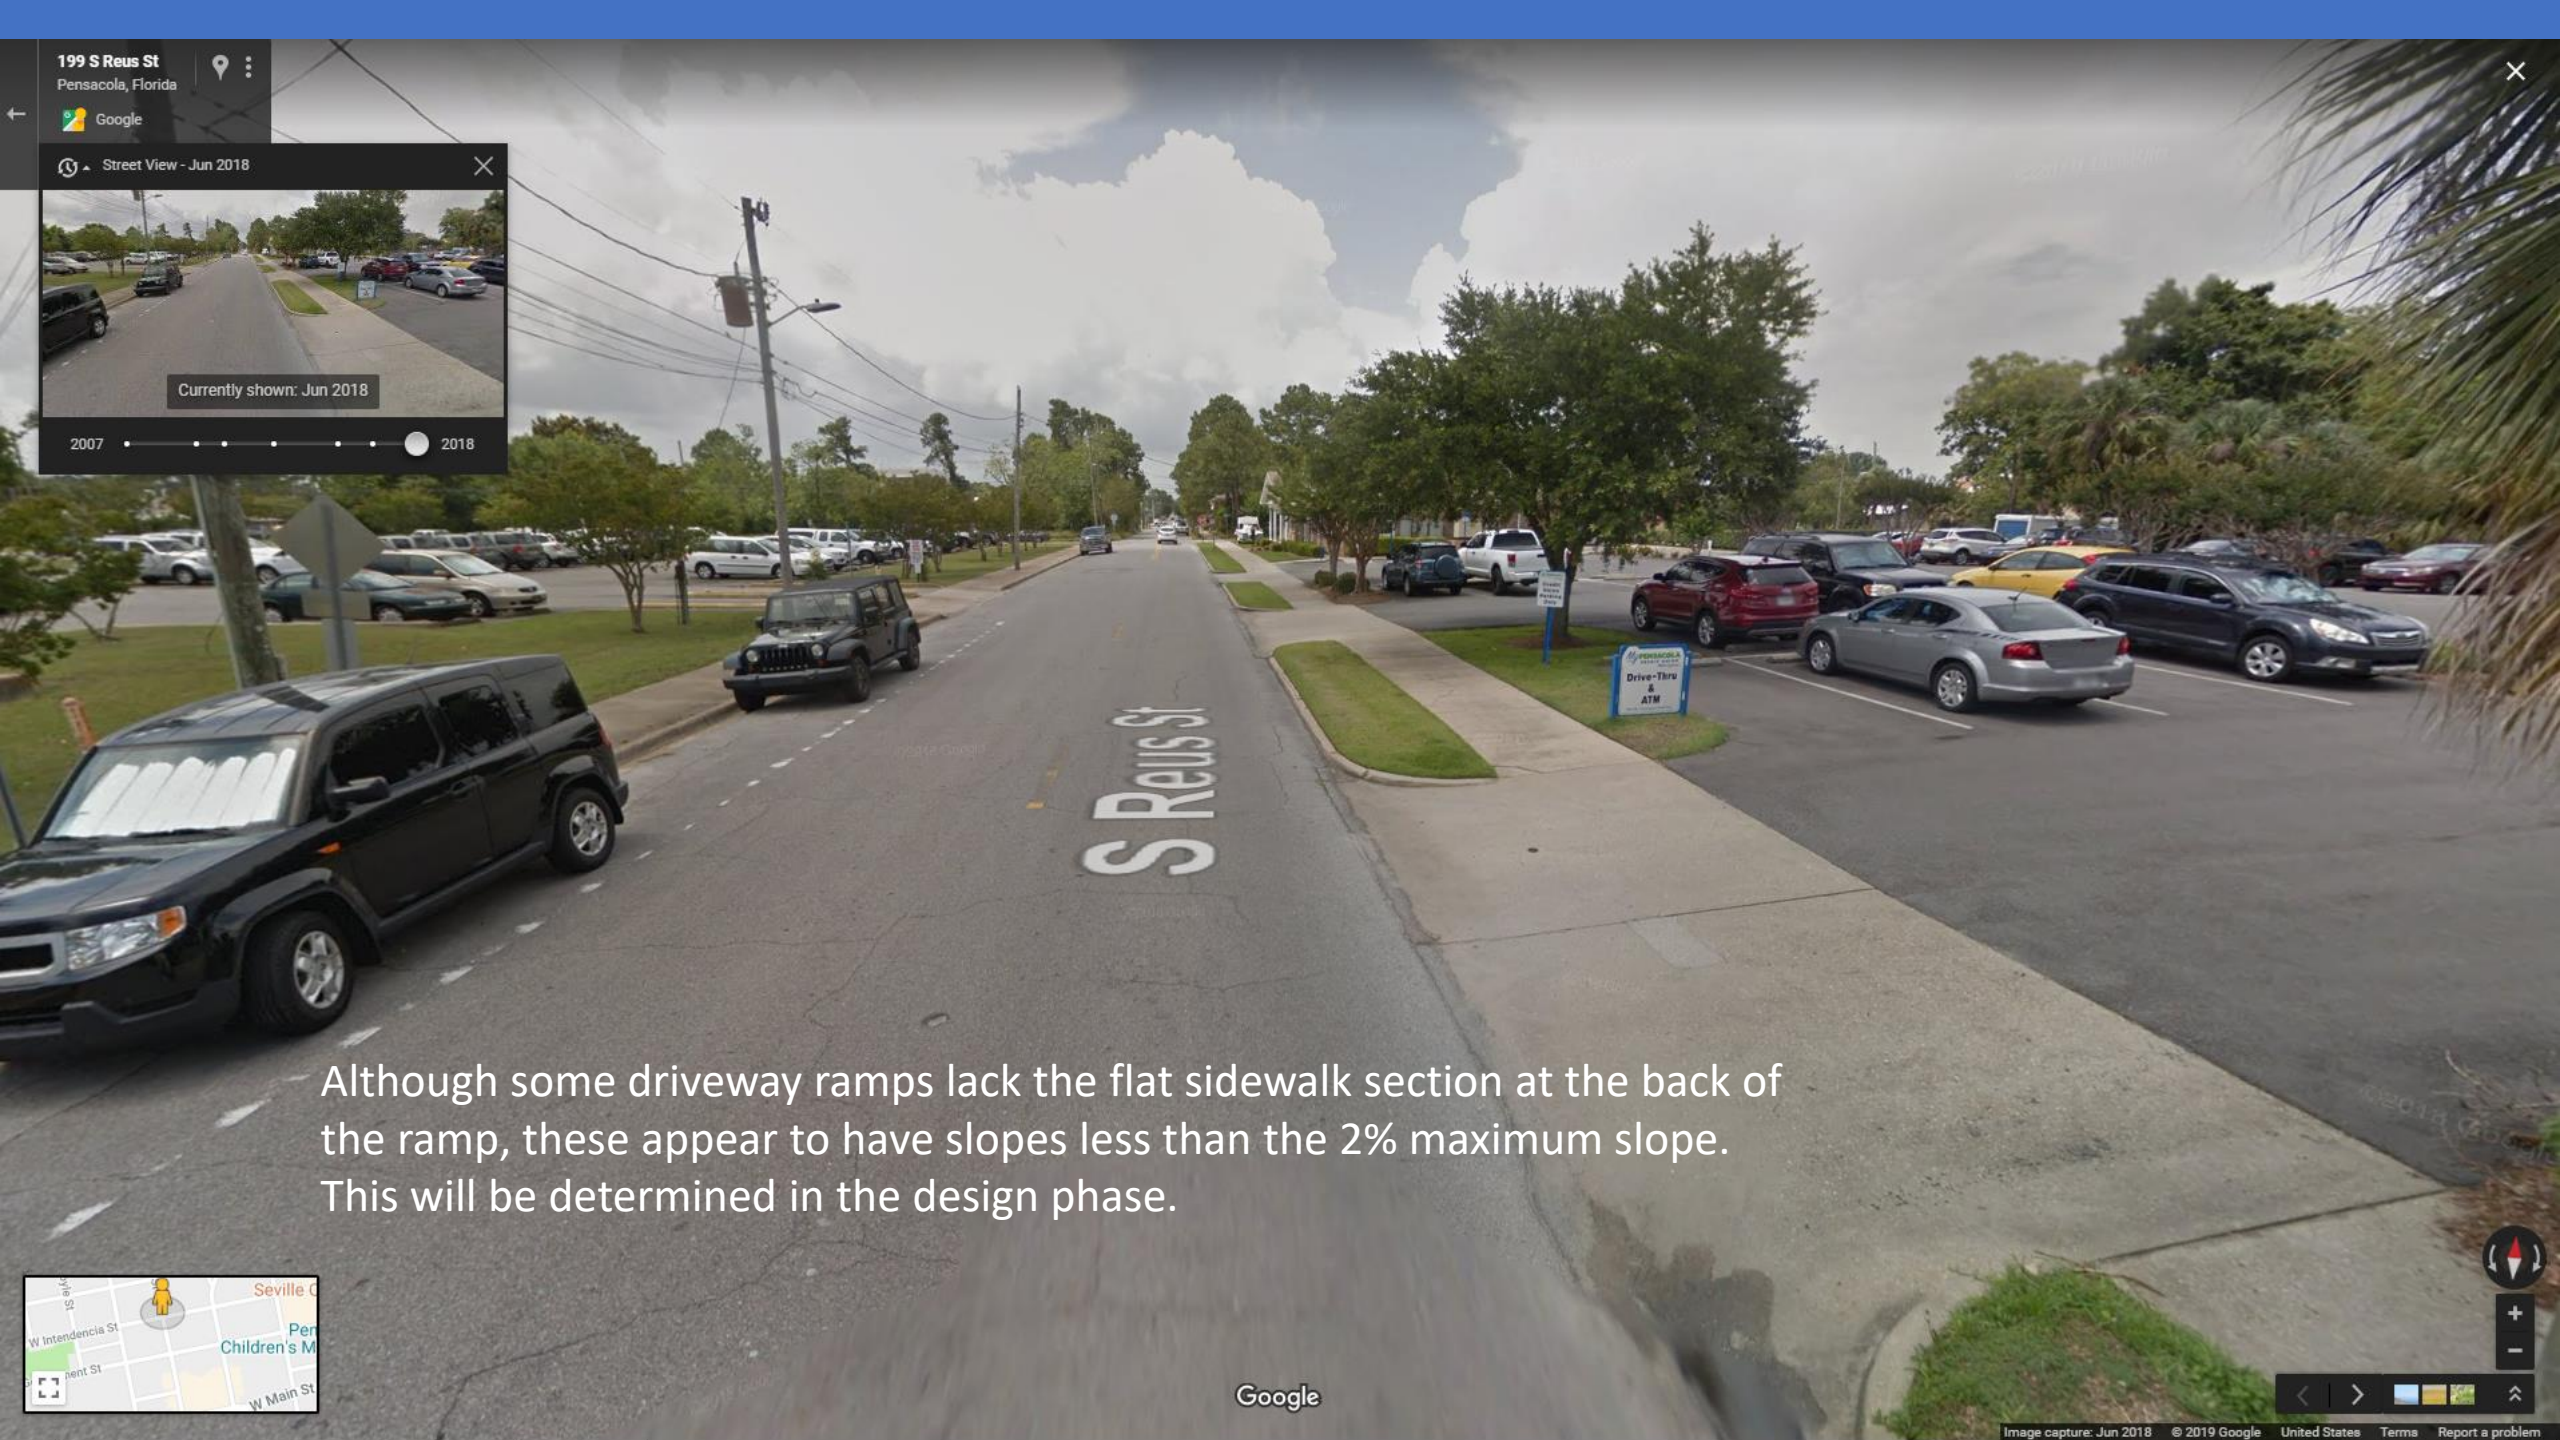
This driveway does not meet the driveway ramp specification with the accessible sidewalk at the back of the ramp. This ramp would be of a type that should be replaced.

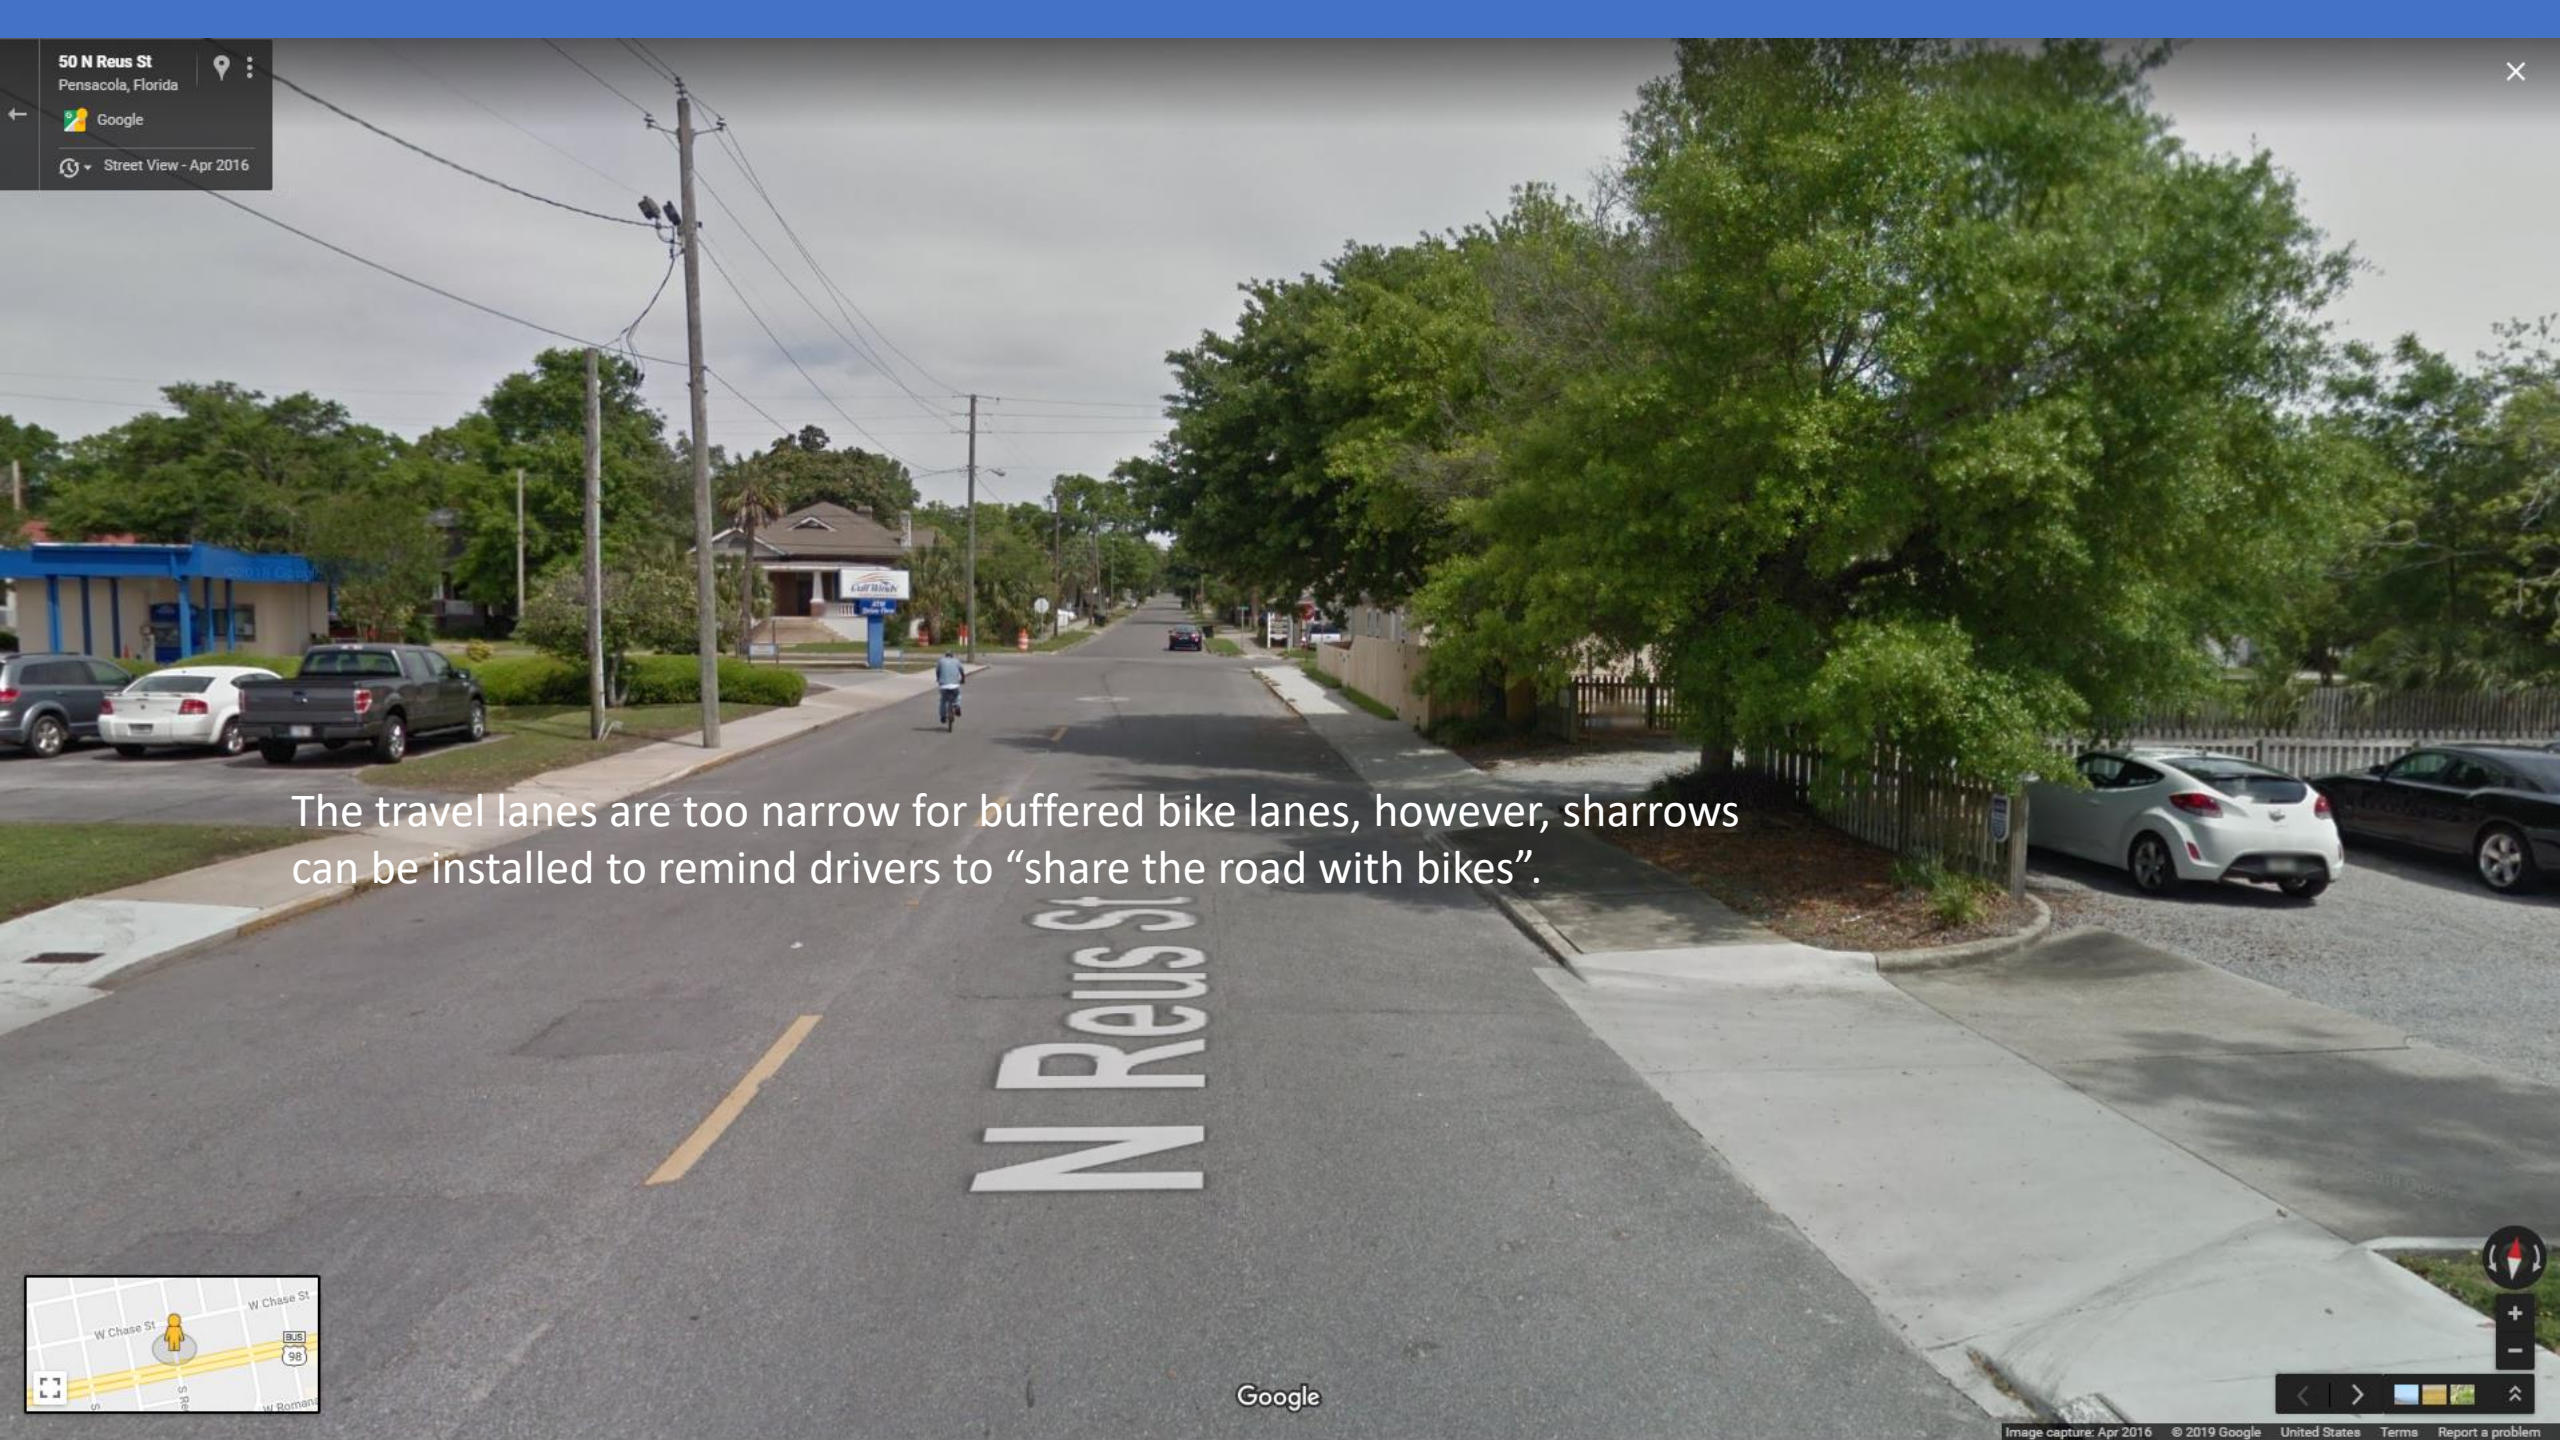
20 N Reus St  
Pensacola, Florida

The travel lanes are too narrow for buffered bike lanes, however, sharrows can be installed to remind drivers to “share the road with bikes”.

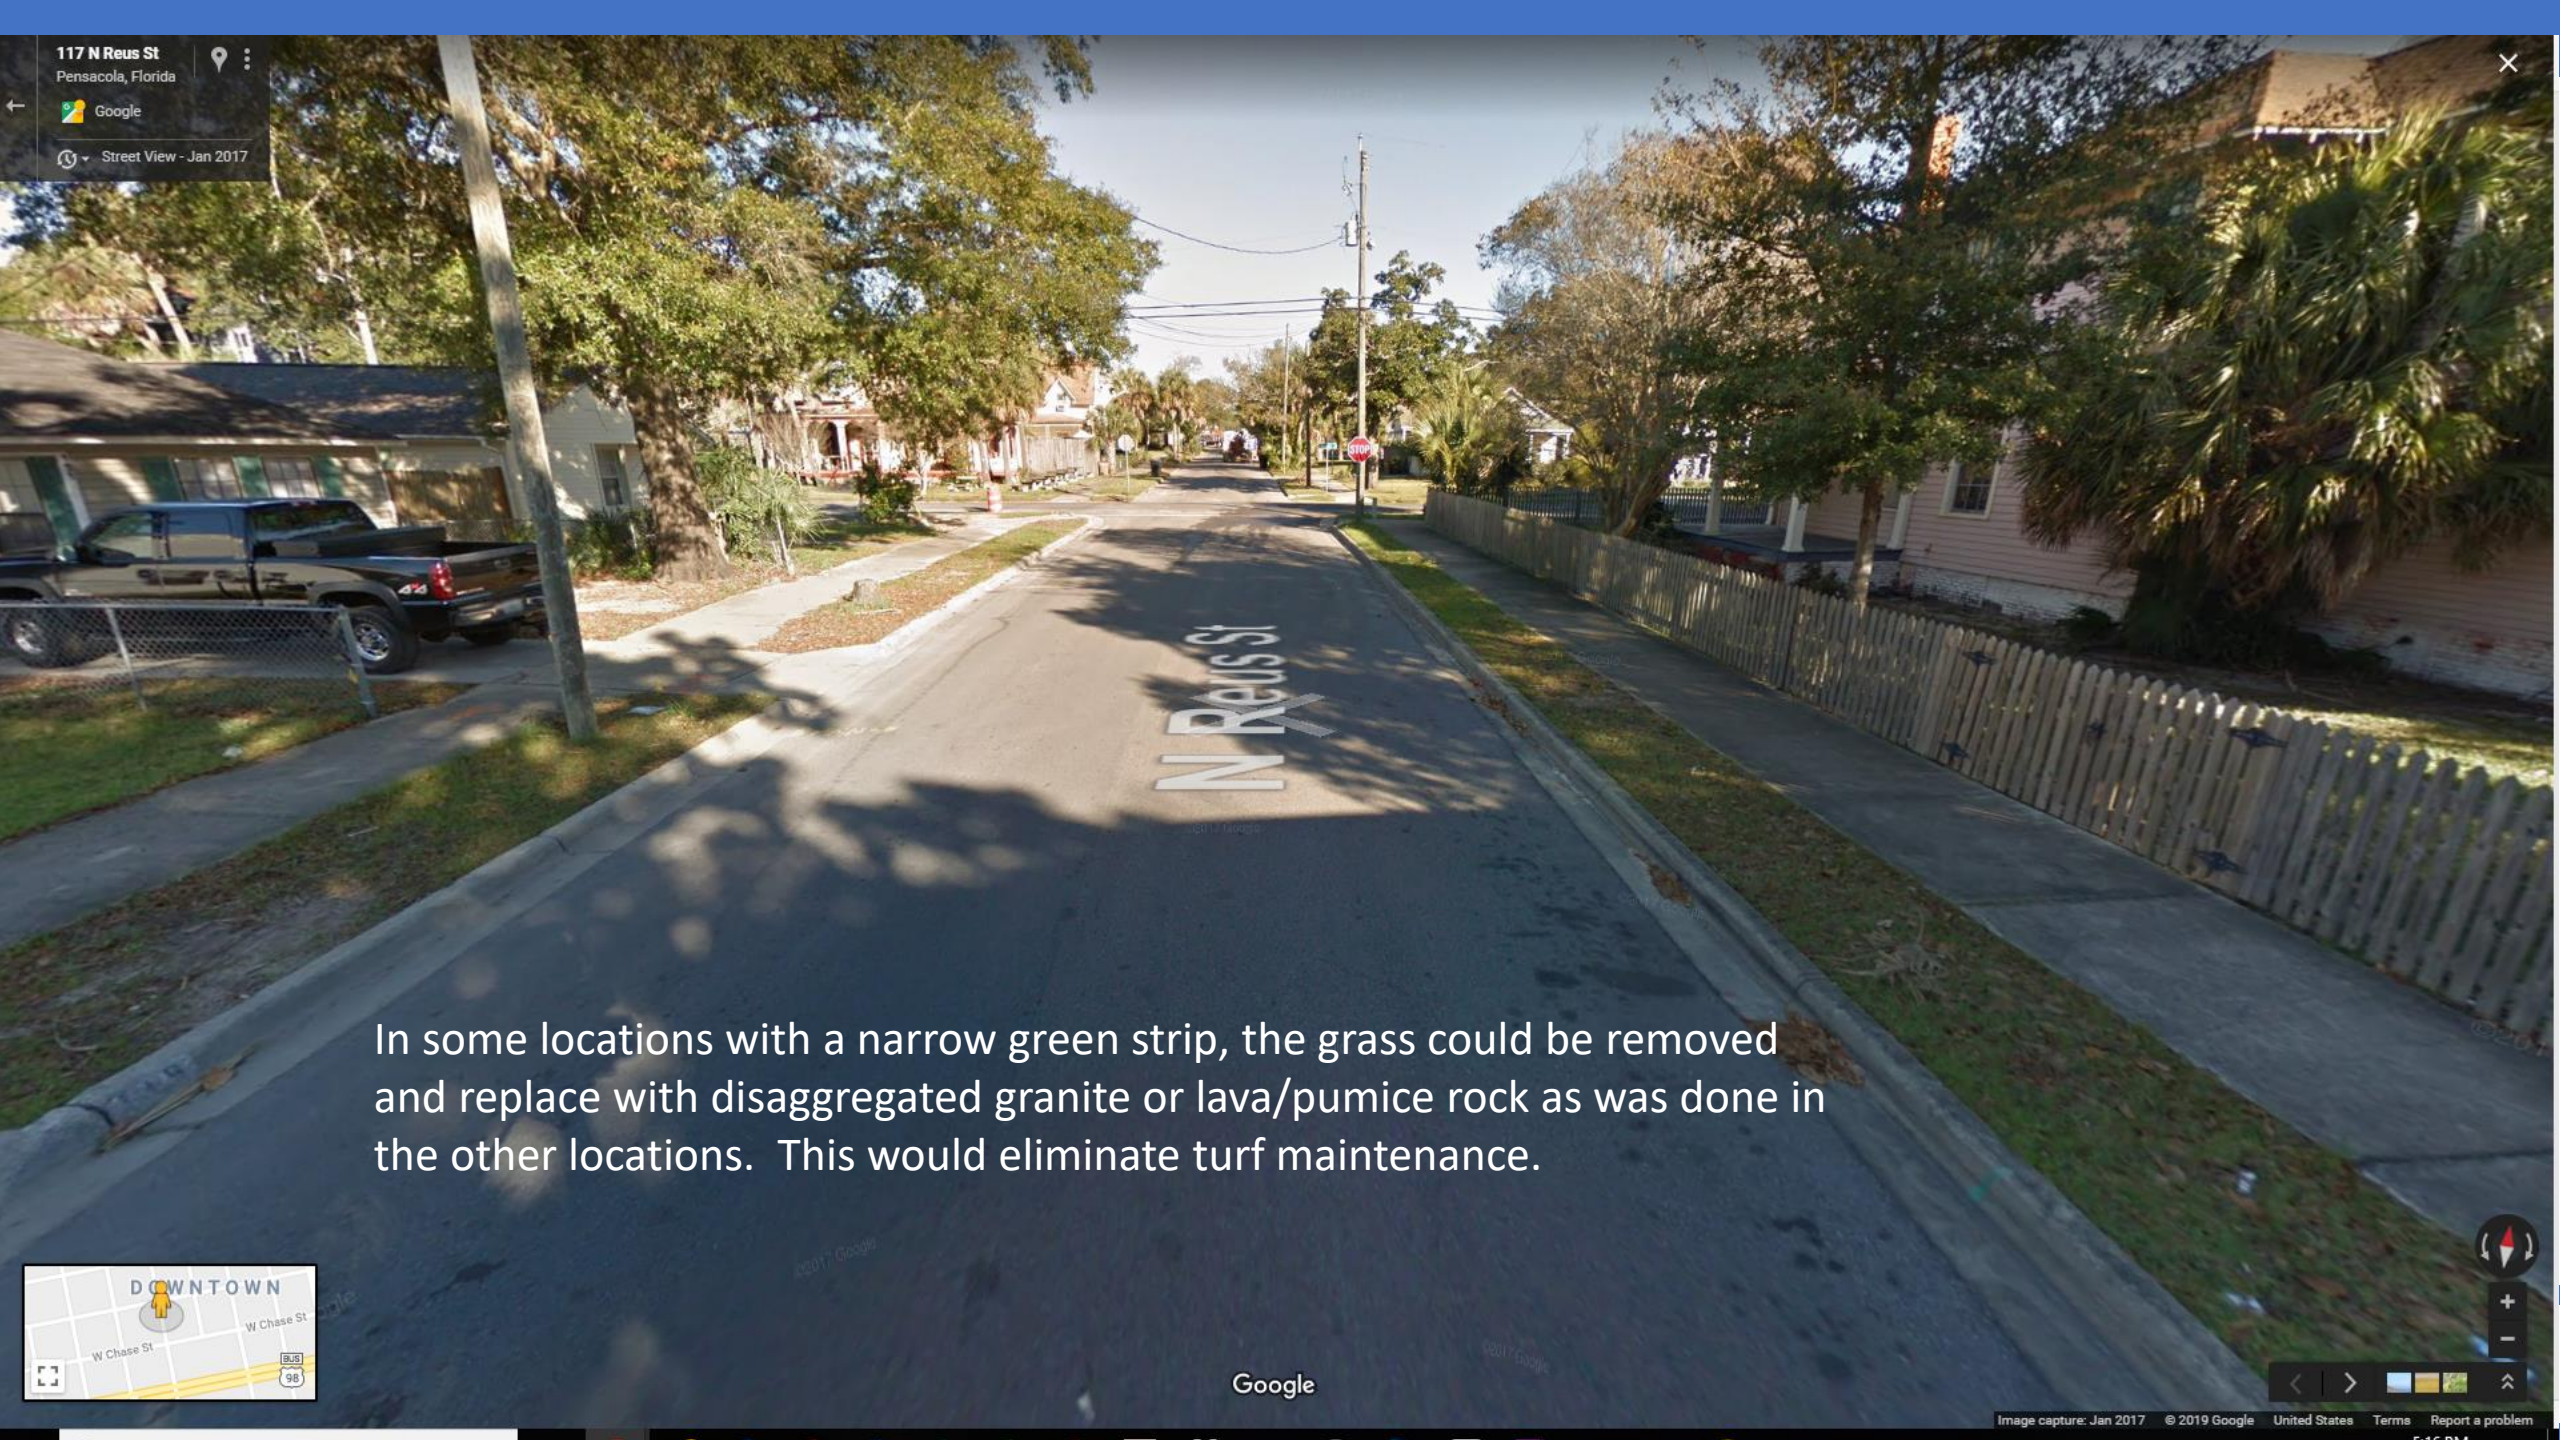
In some locations with a narrow green strip, the grass could be removed and replace with disaggregated granite or lava/pumice rock as was done in the other locations. This would eliminate turf maintenance.

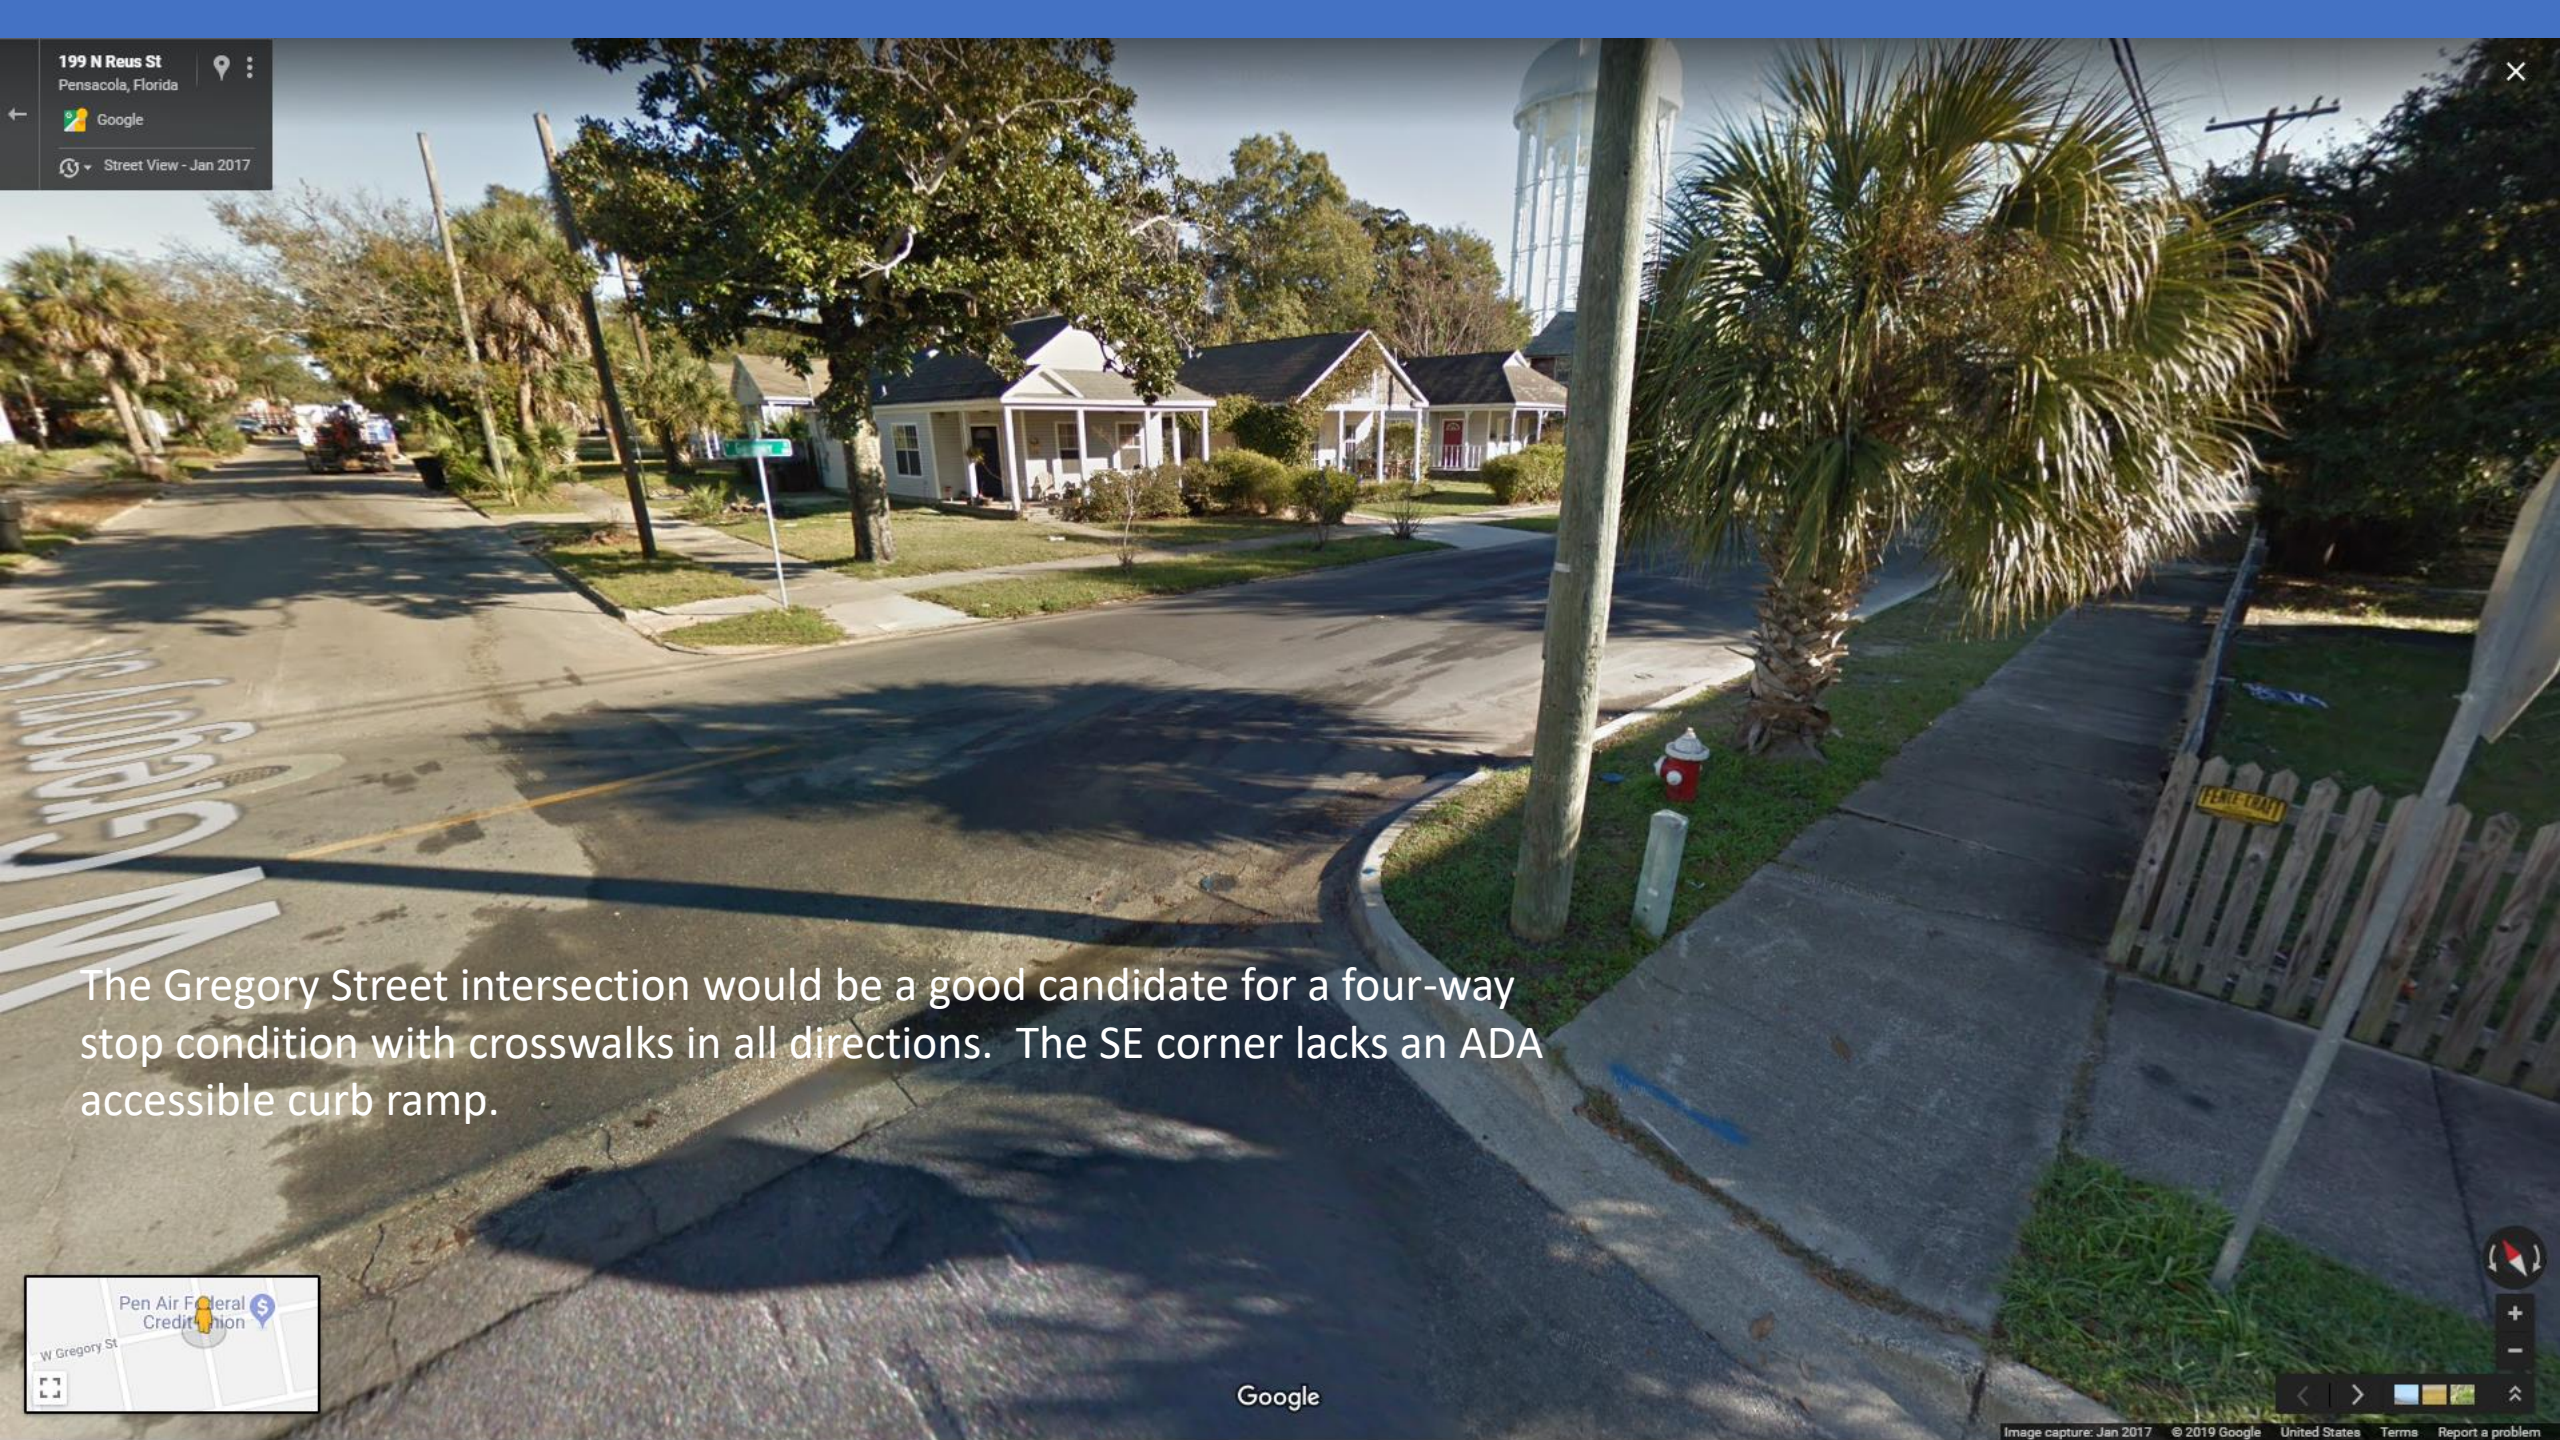
199 N Reus St  
Pensacola, Florida

The Gregory Street intersection would be a good candidate for a four-way stop condition with crosswalks in all directions. The SE corner lacks an ADA accessible curb ramp.

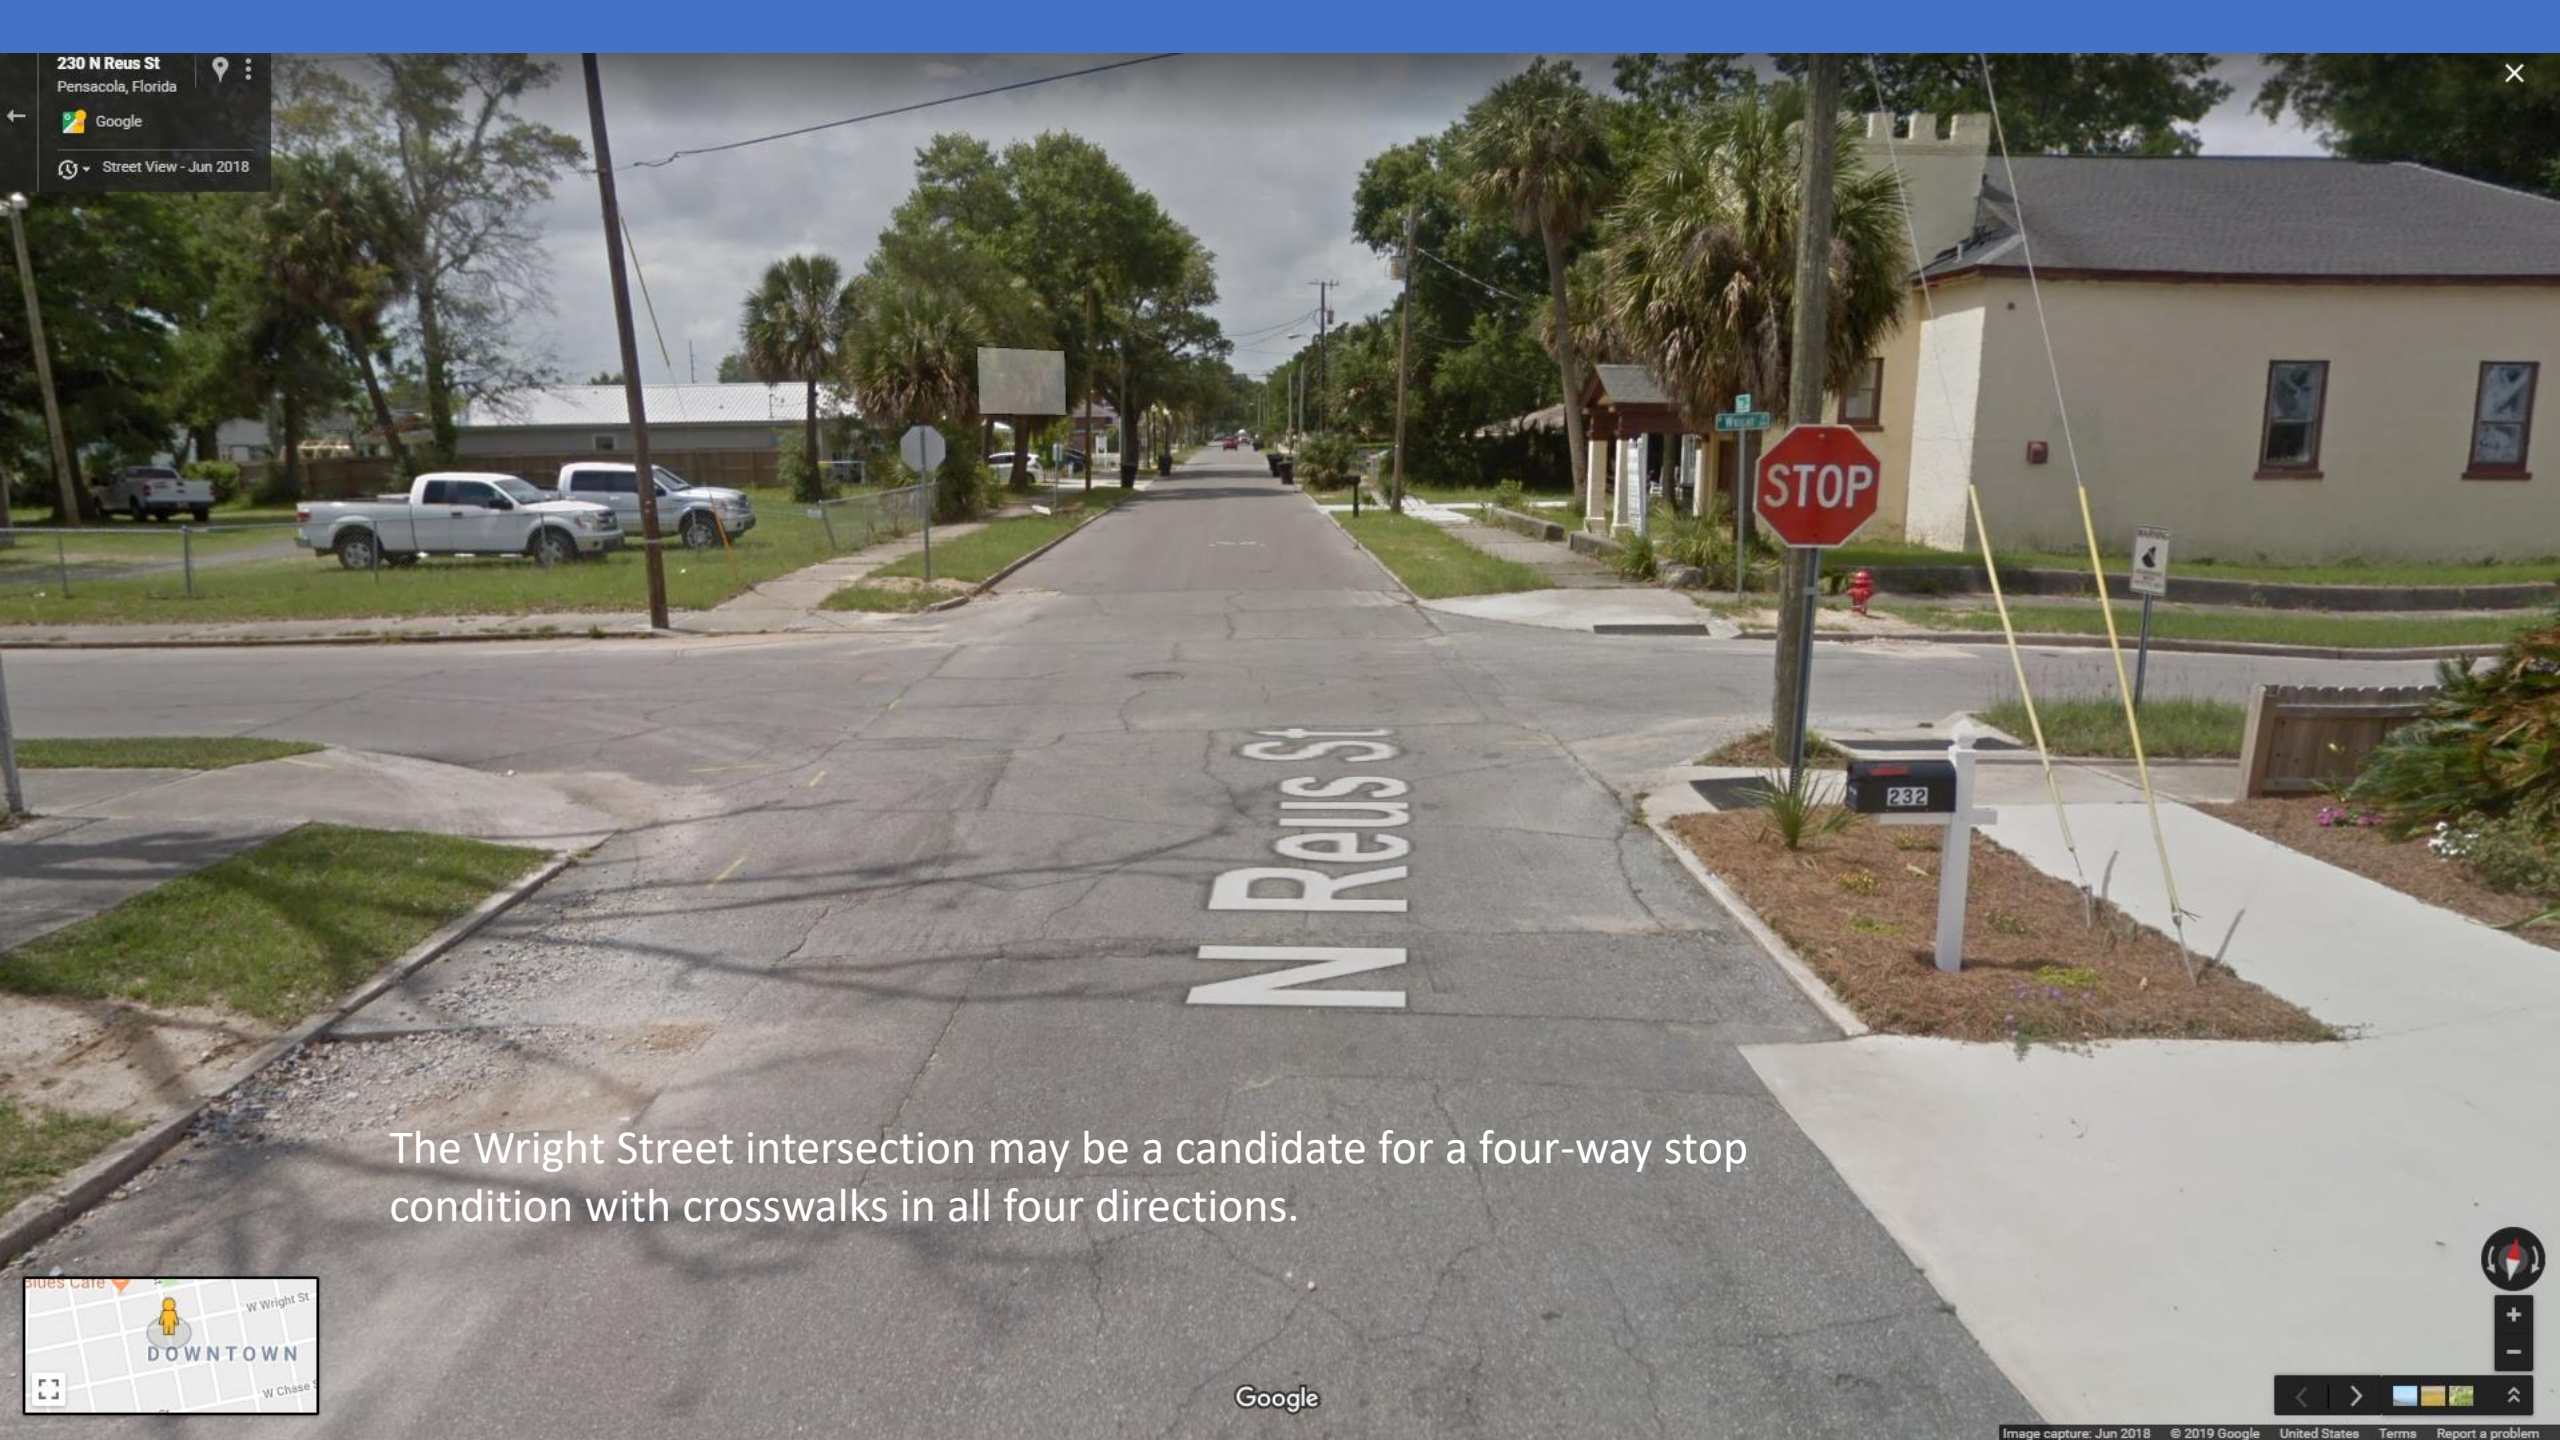
230 N Reus St  
Pensacola, Florida  
Google  
Street View - Jun 2018

The Wright Street intersection may be a candidate for a four-way stop condition with crosswalks in all four directions.

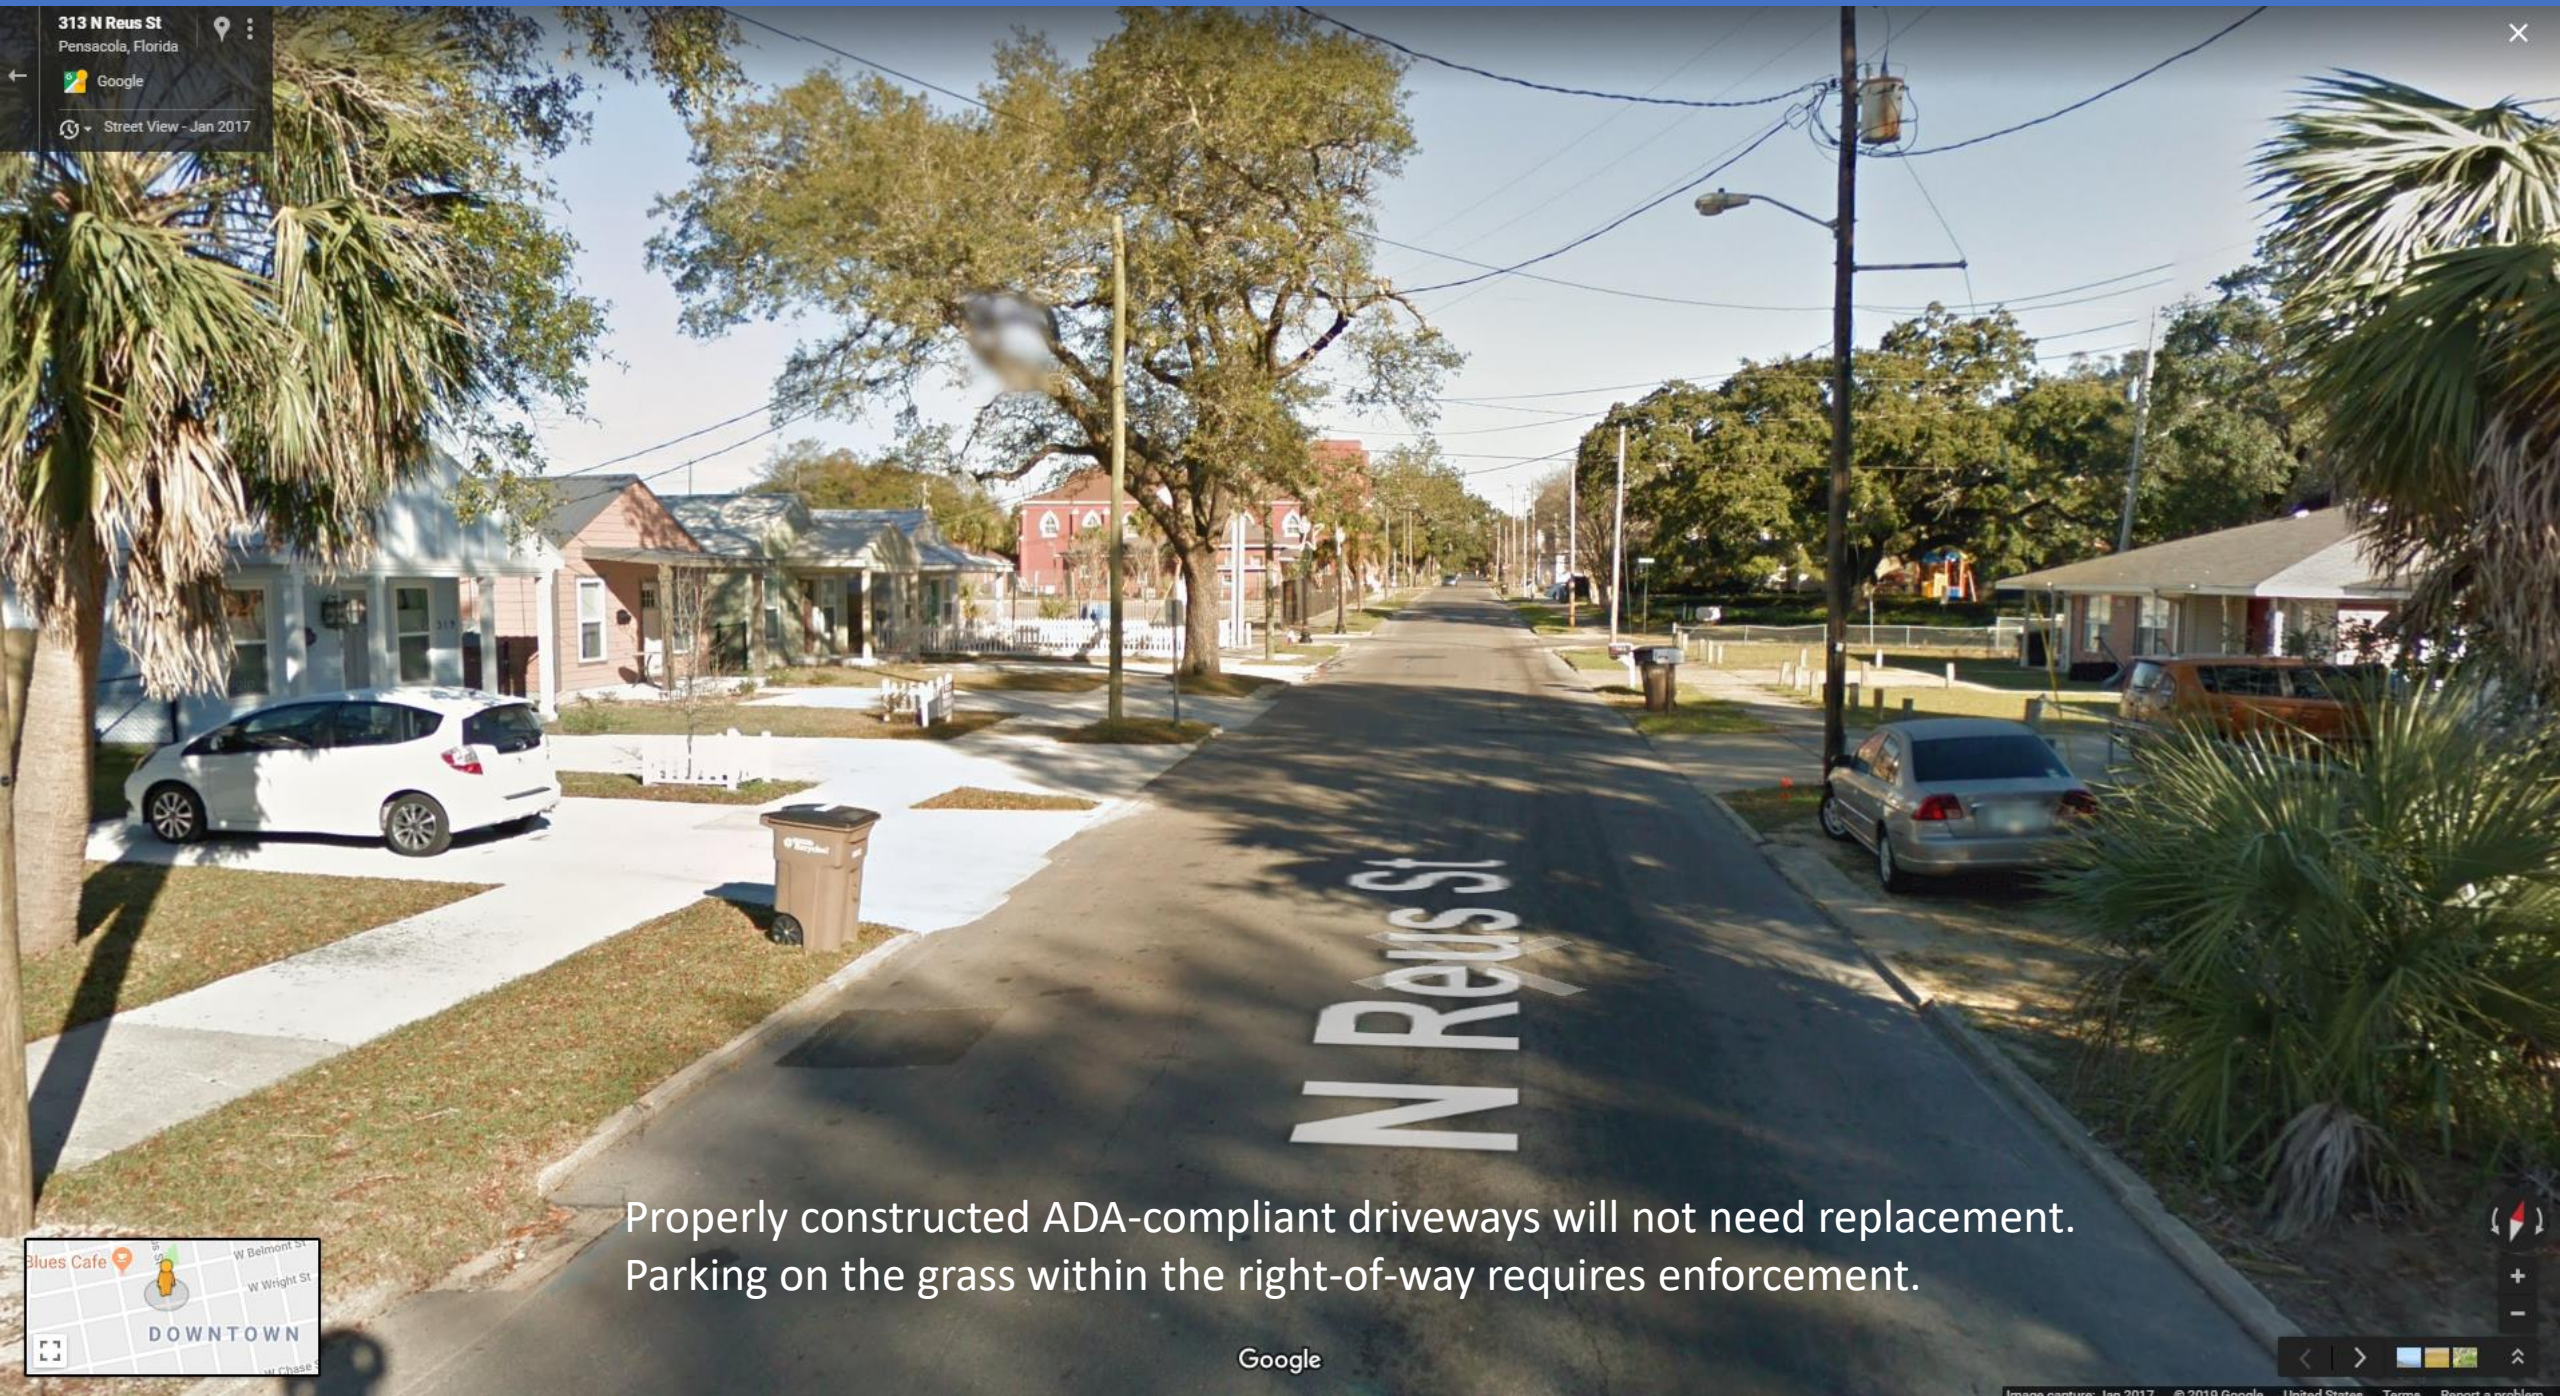
Properly constructed ADA-compliant driveways will not need replacement.  
Parking on the grass within the right-of-way requires enforcement.

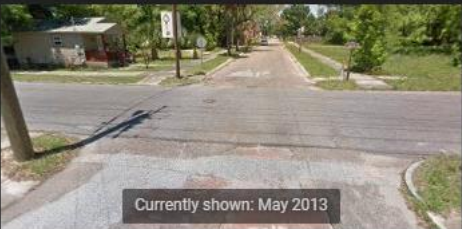
Remnants of the old brick streets still exist in many locations.  
Jackson Street is also a candidate for a four-way stop condition.

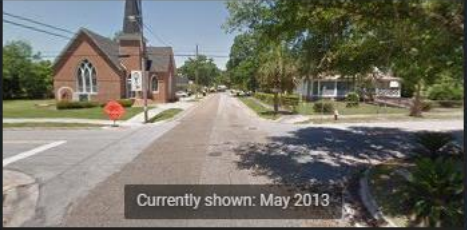
Gadsden Street is a stop condition and is also a candidate for a four-way stop.
